## APPENDIX A

# Habitat Assessment Figures

## APPENDIX B

# Habitat Conditions Described by Reach-Based Ecosystem Indicators

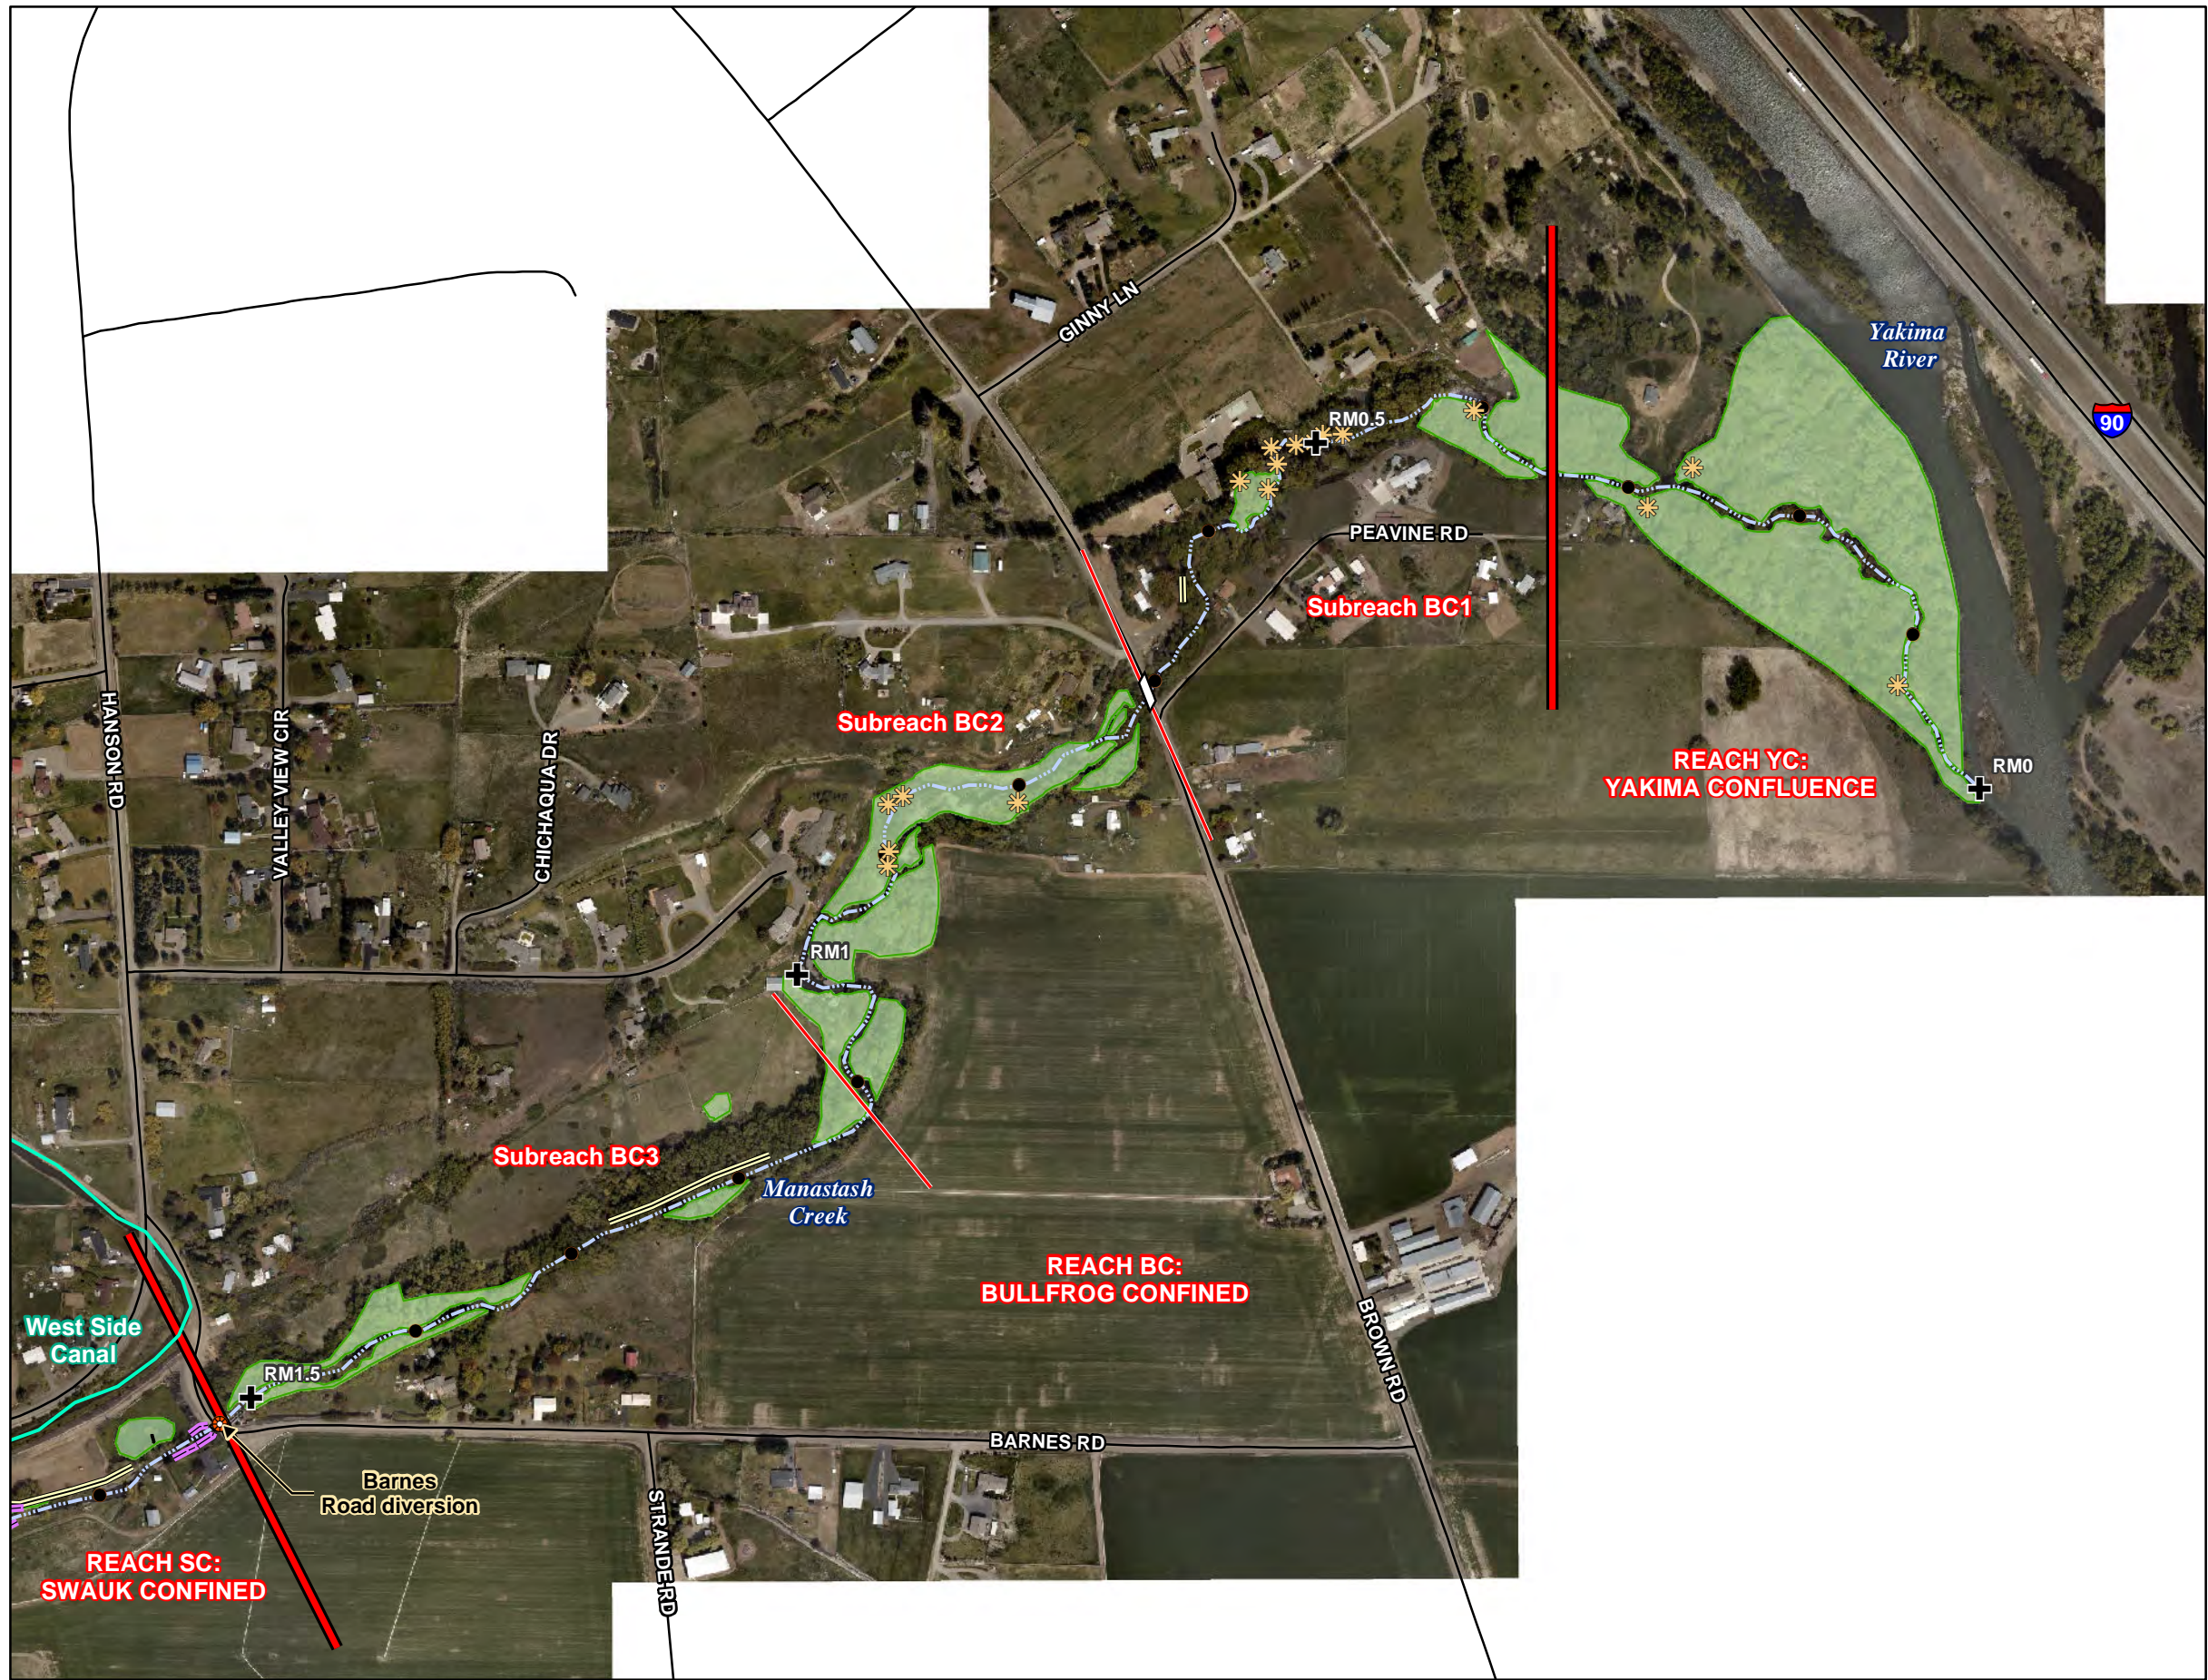
Figure A2.  
Yakima Confluence (Reach YC) and  
Bullfrog Confined (Reach BC) habitat  
conditions.

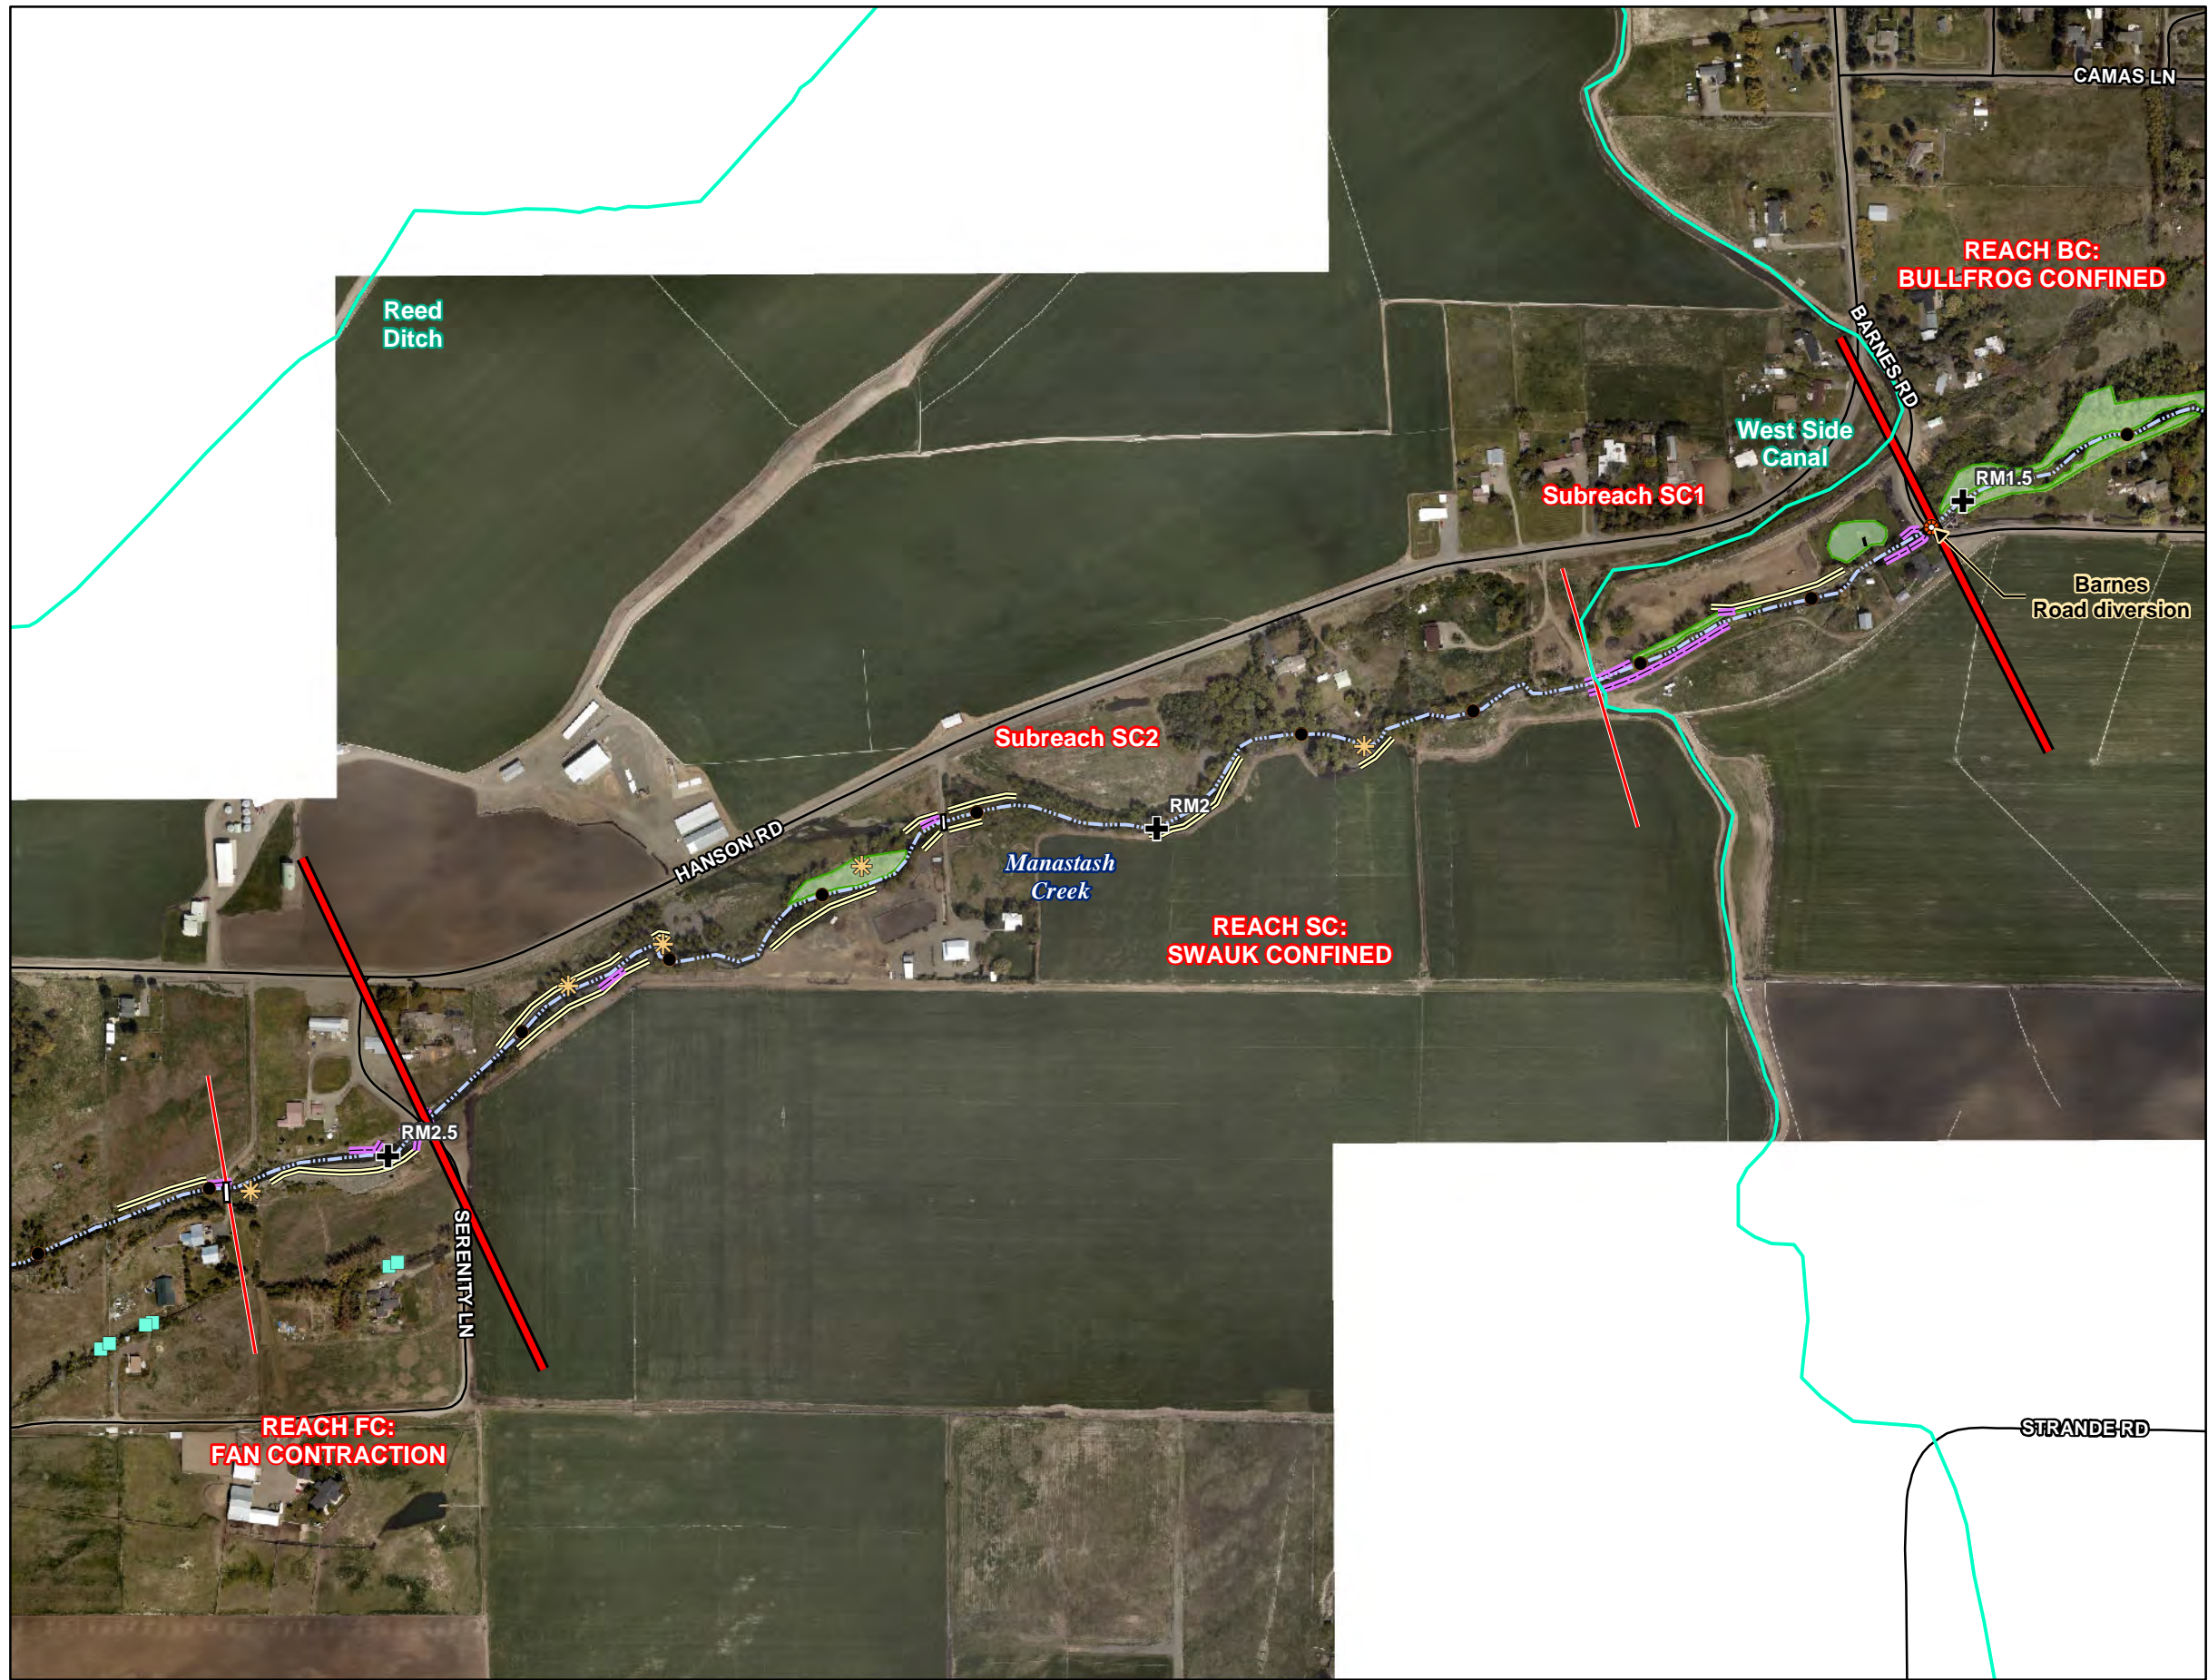
Figure A3.  
Swauk Confinement (Reach SC) habitat  
conditions.

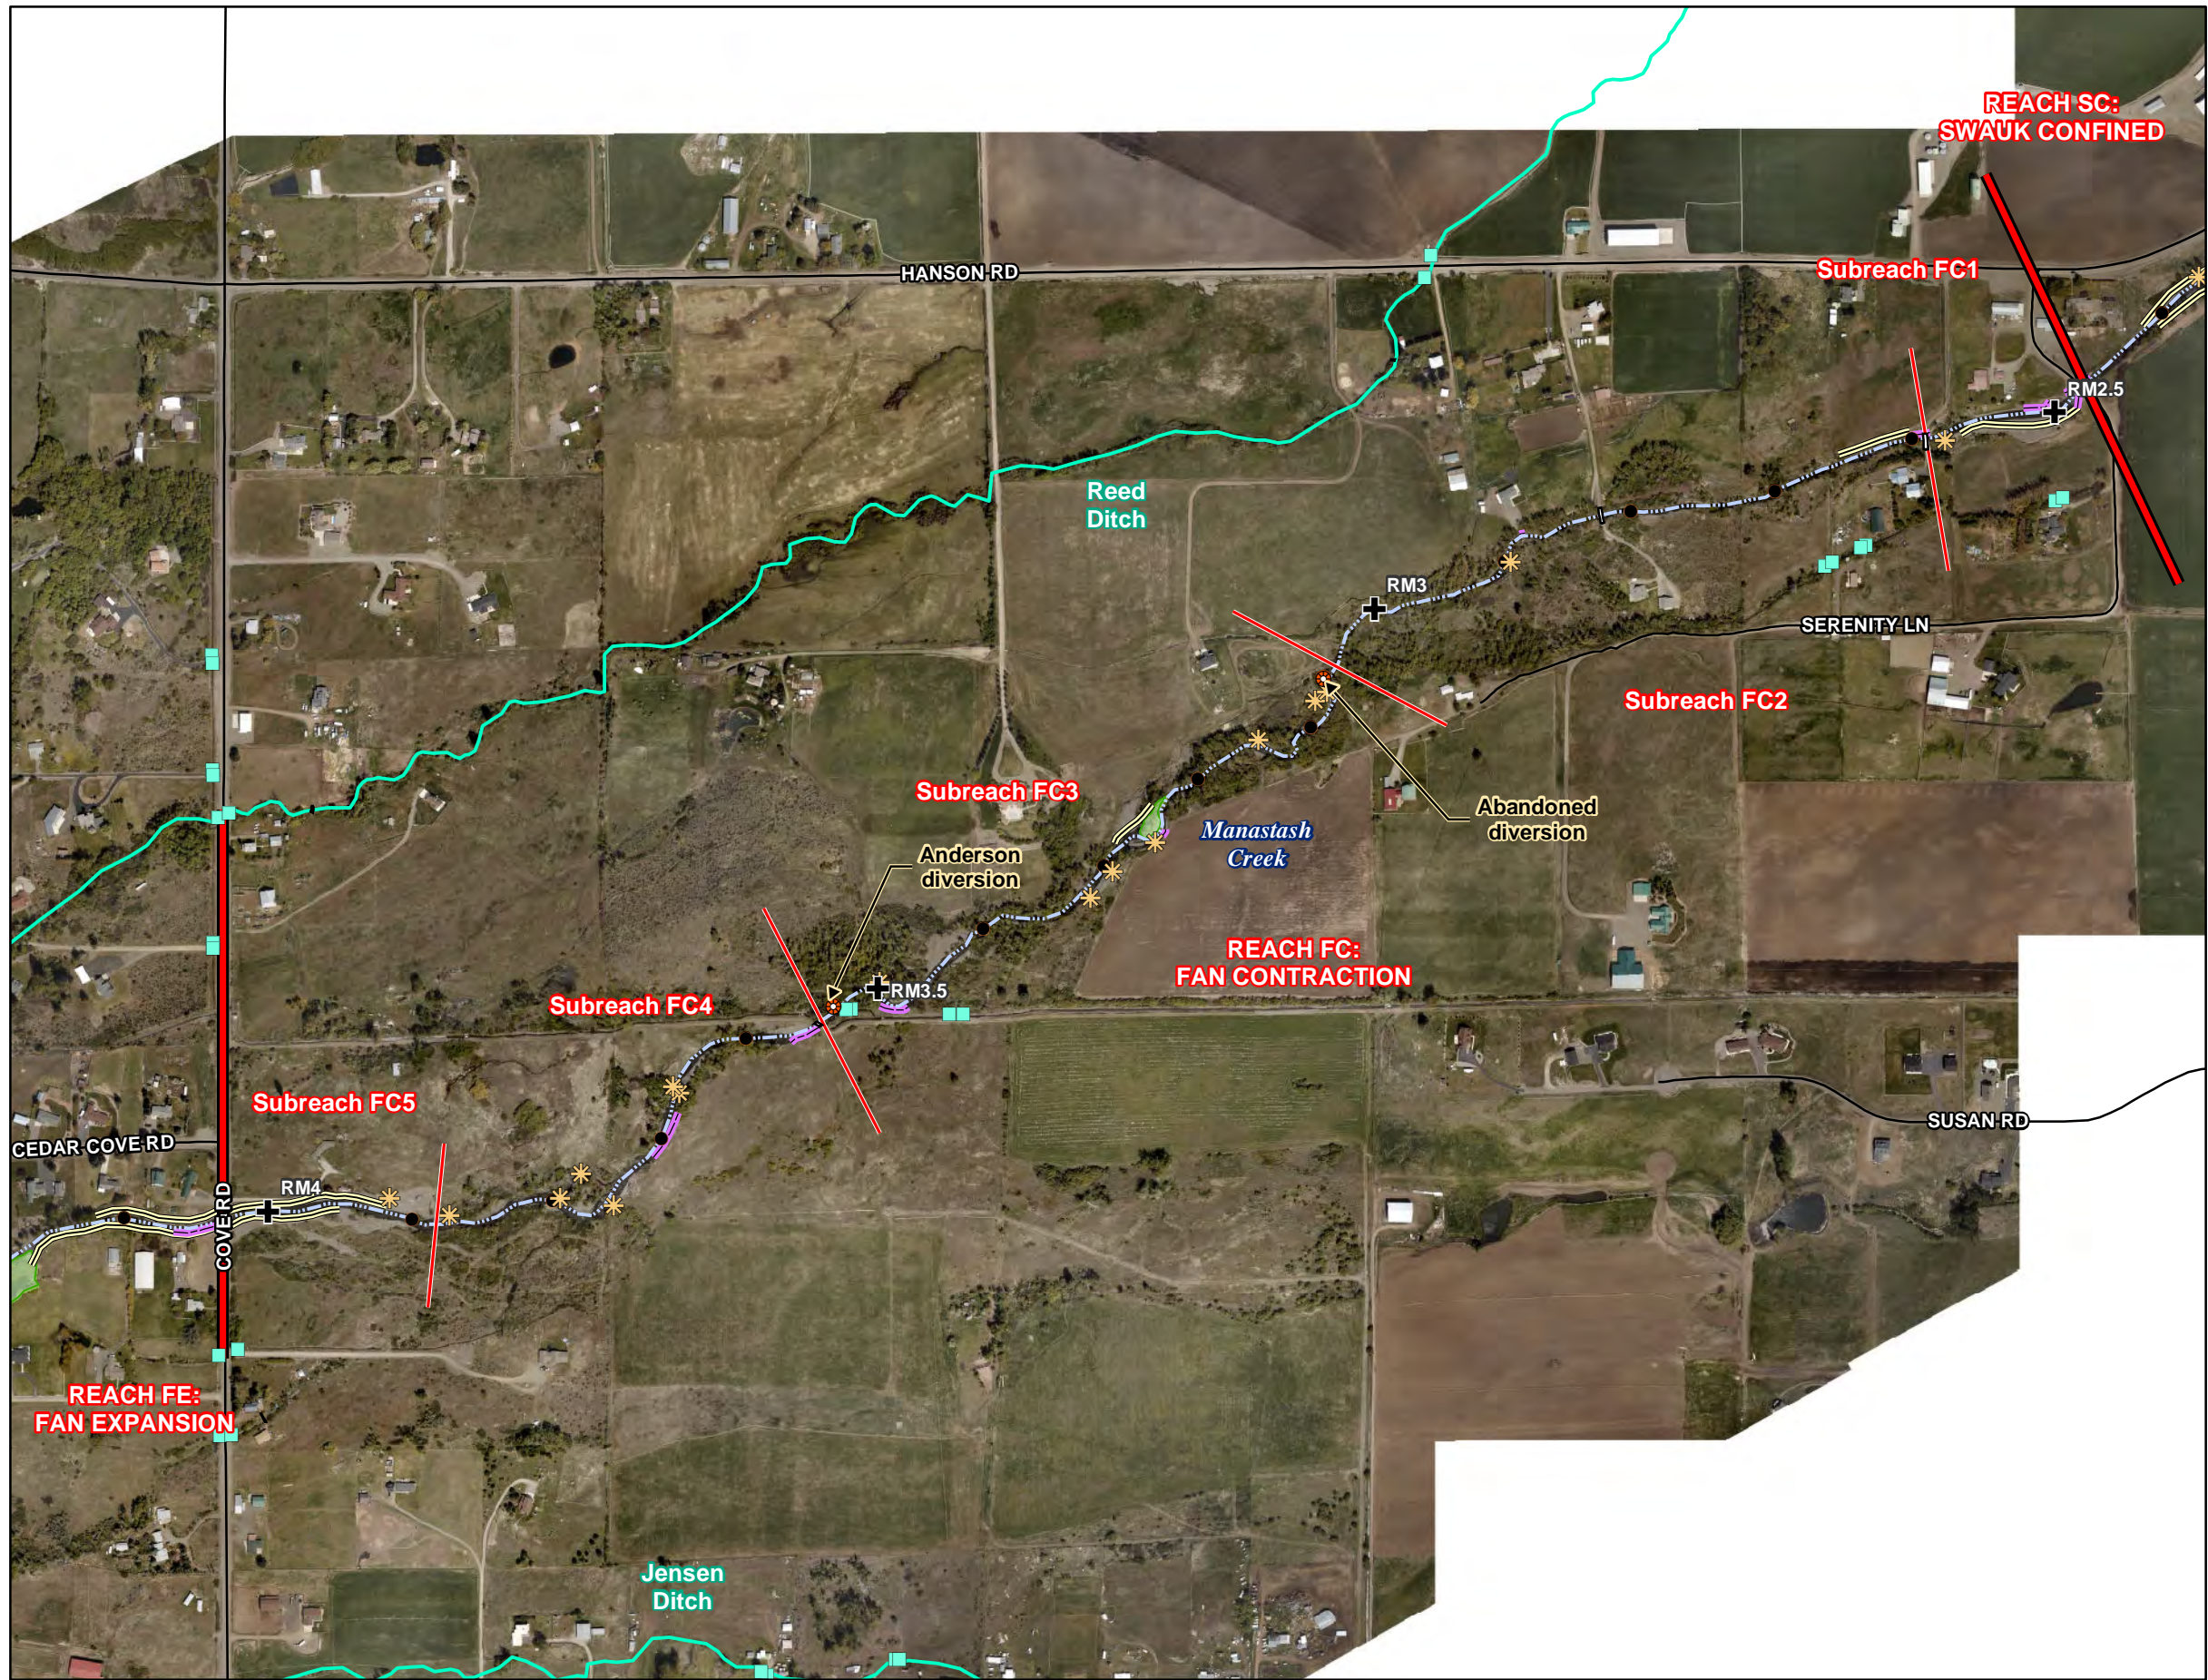
Figure A4.  
Fan Contraction (Reach FC) habitat  
conditions.

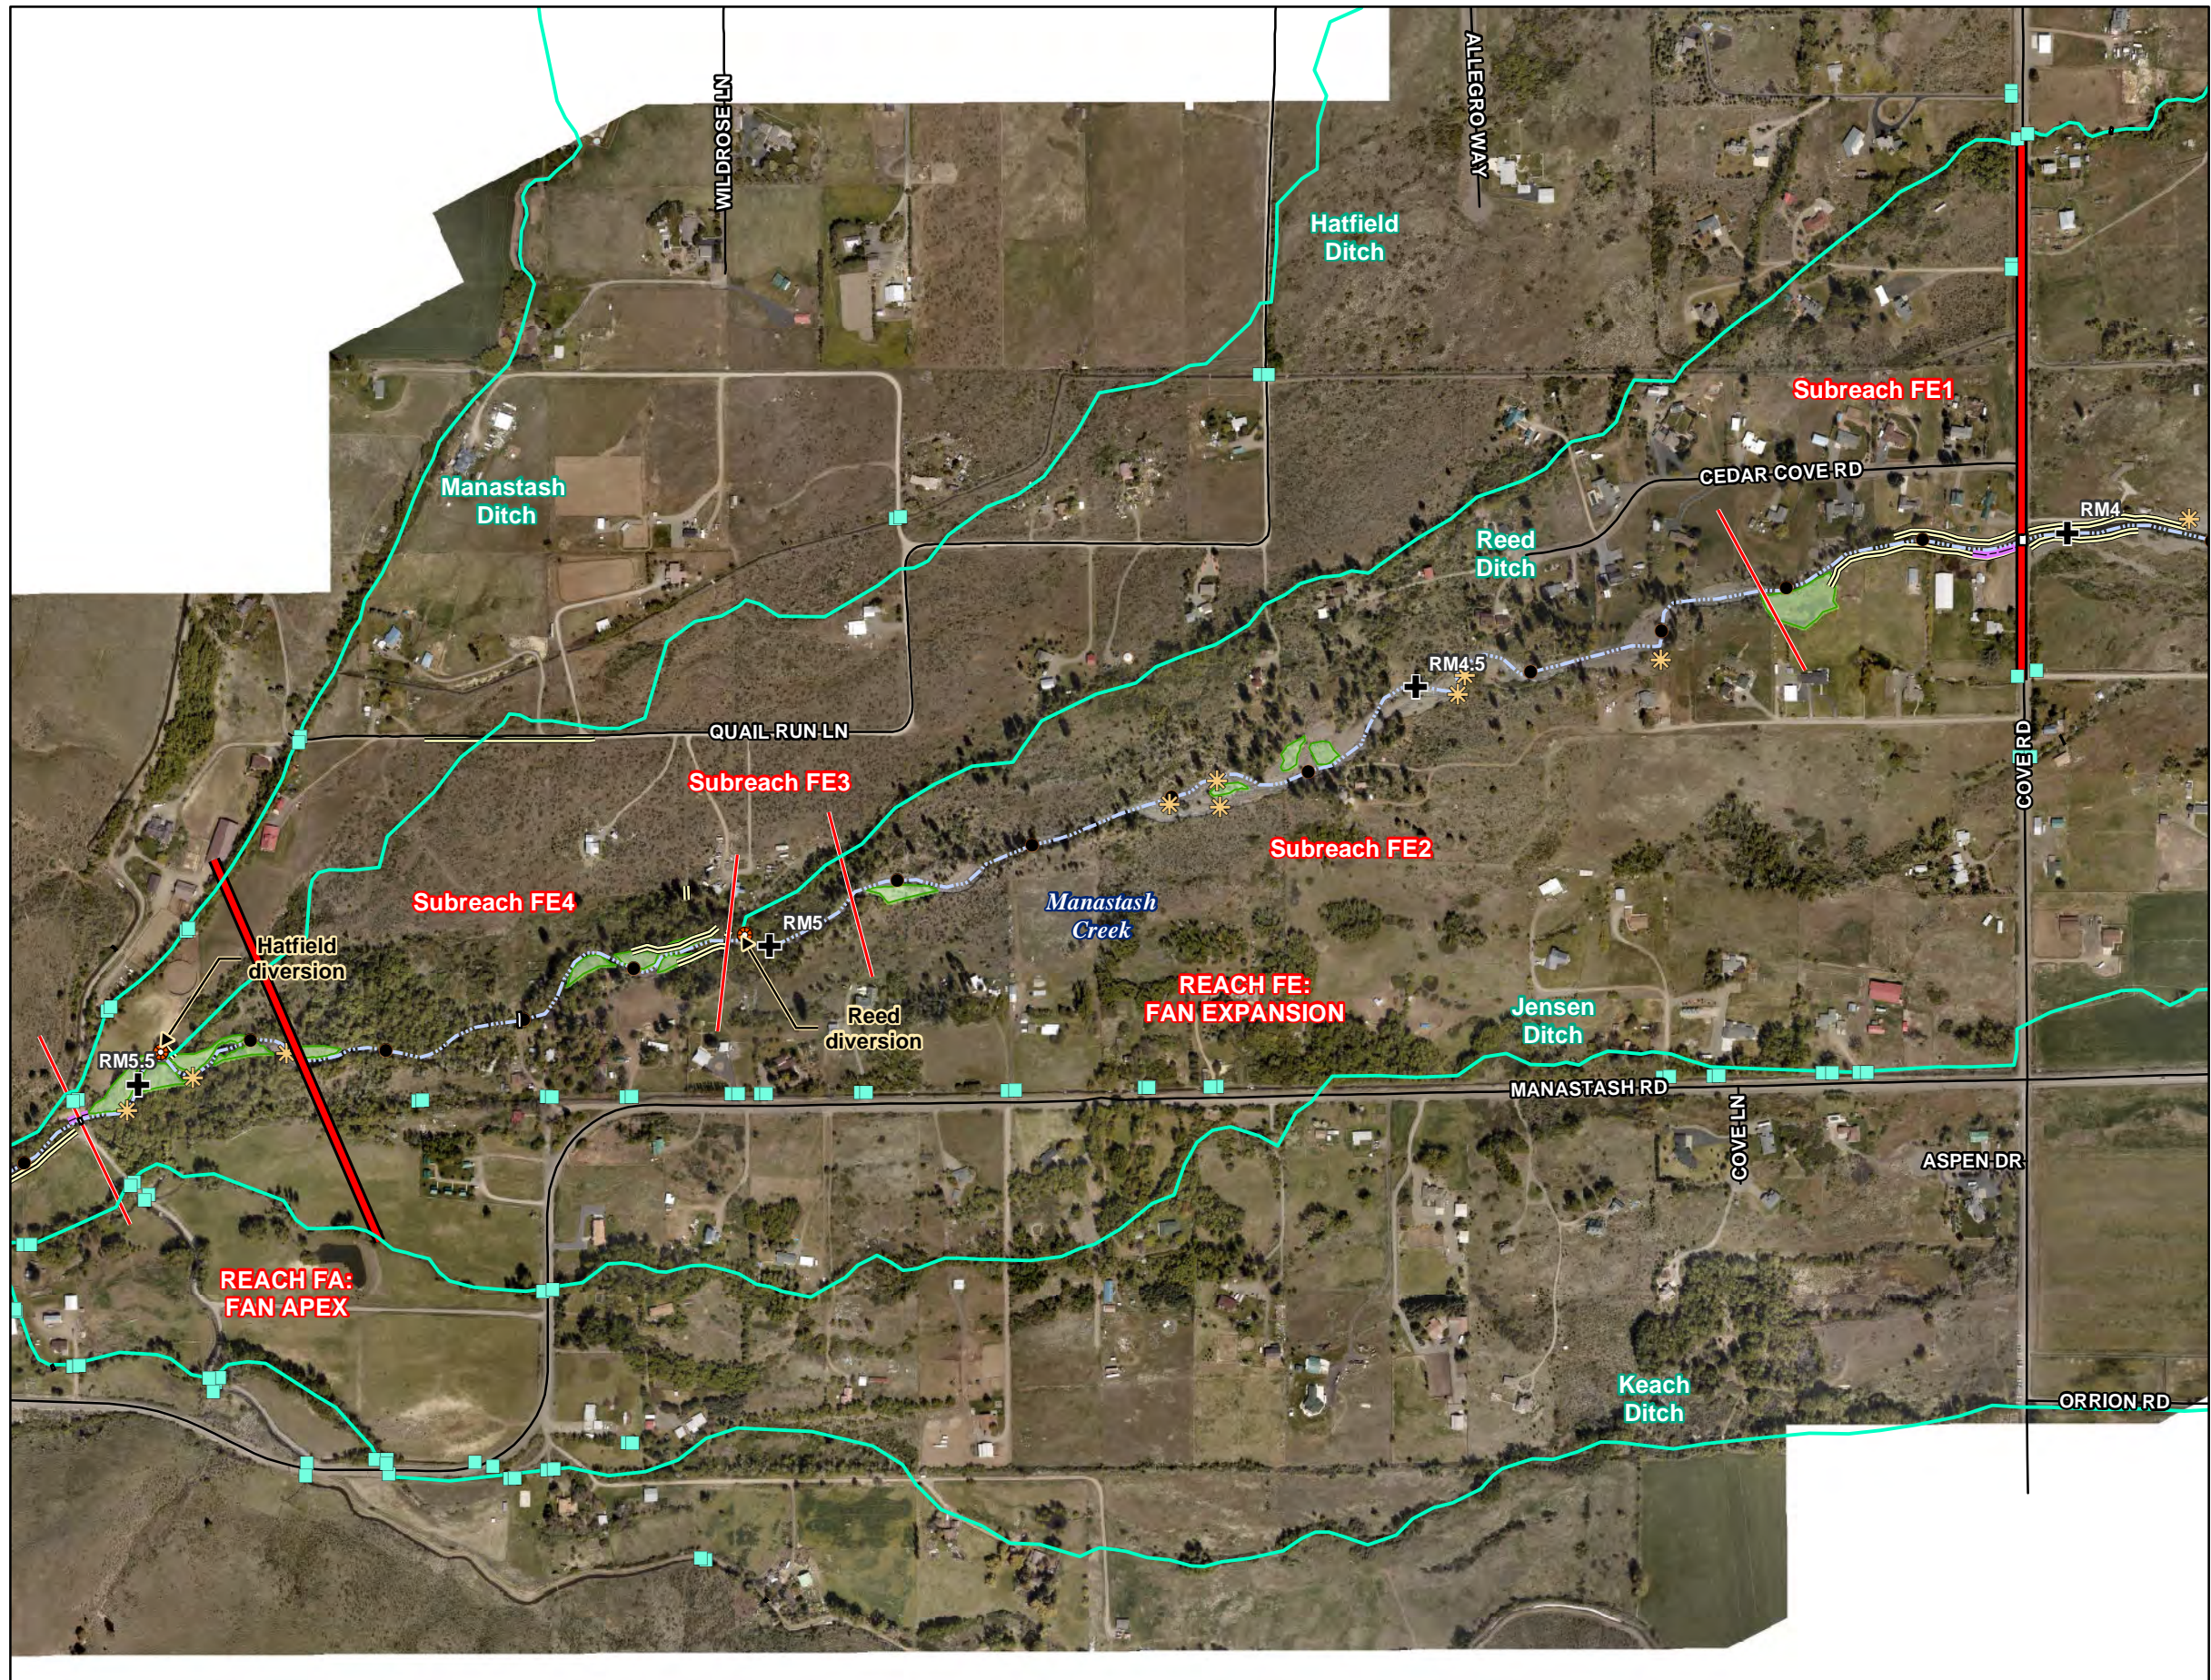
Figure A5.  
Fan Expansion (Reach FE) habitat  
conditions.

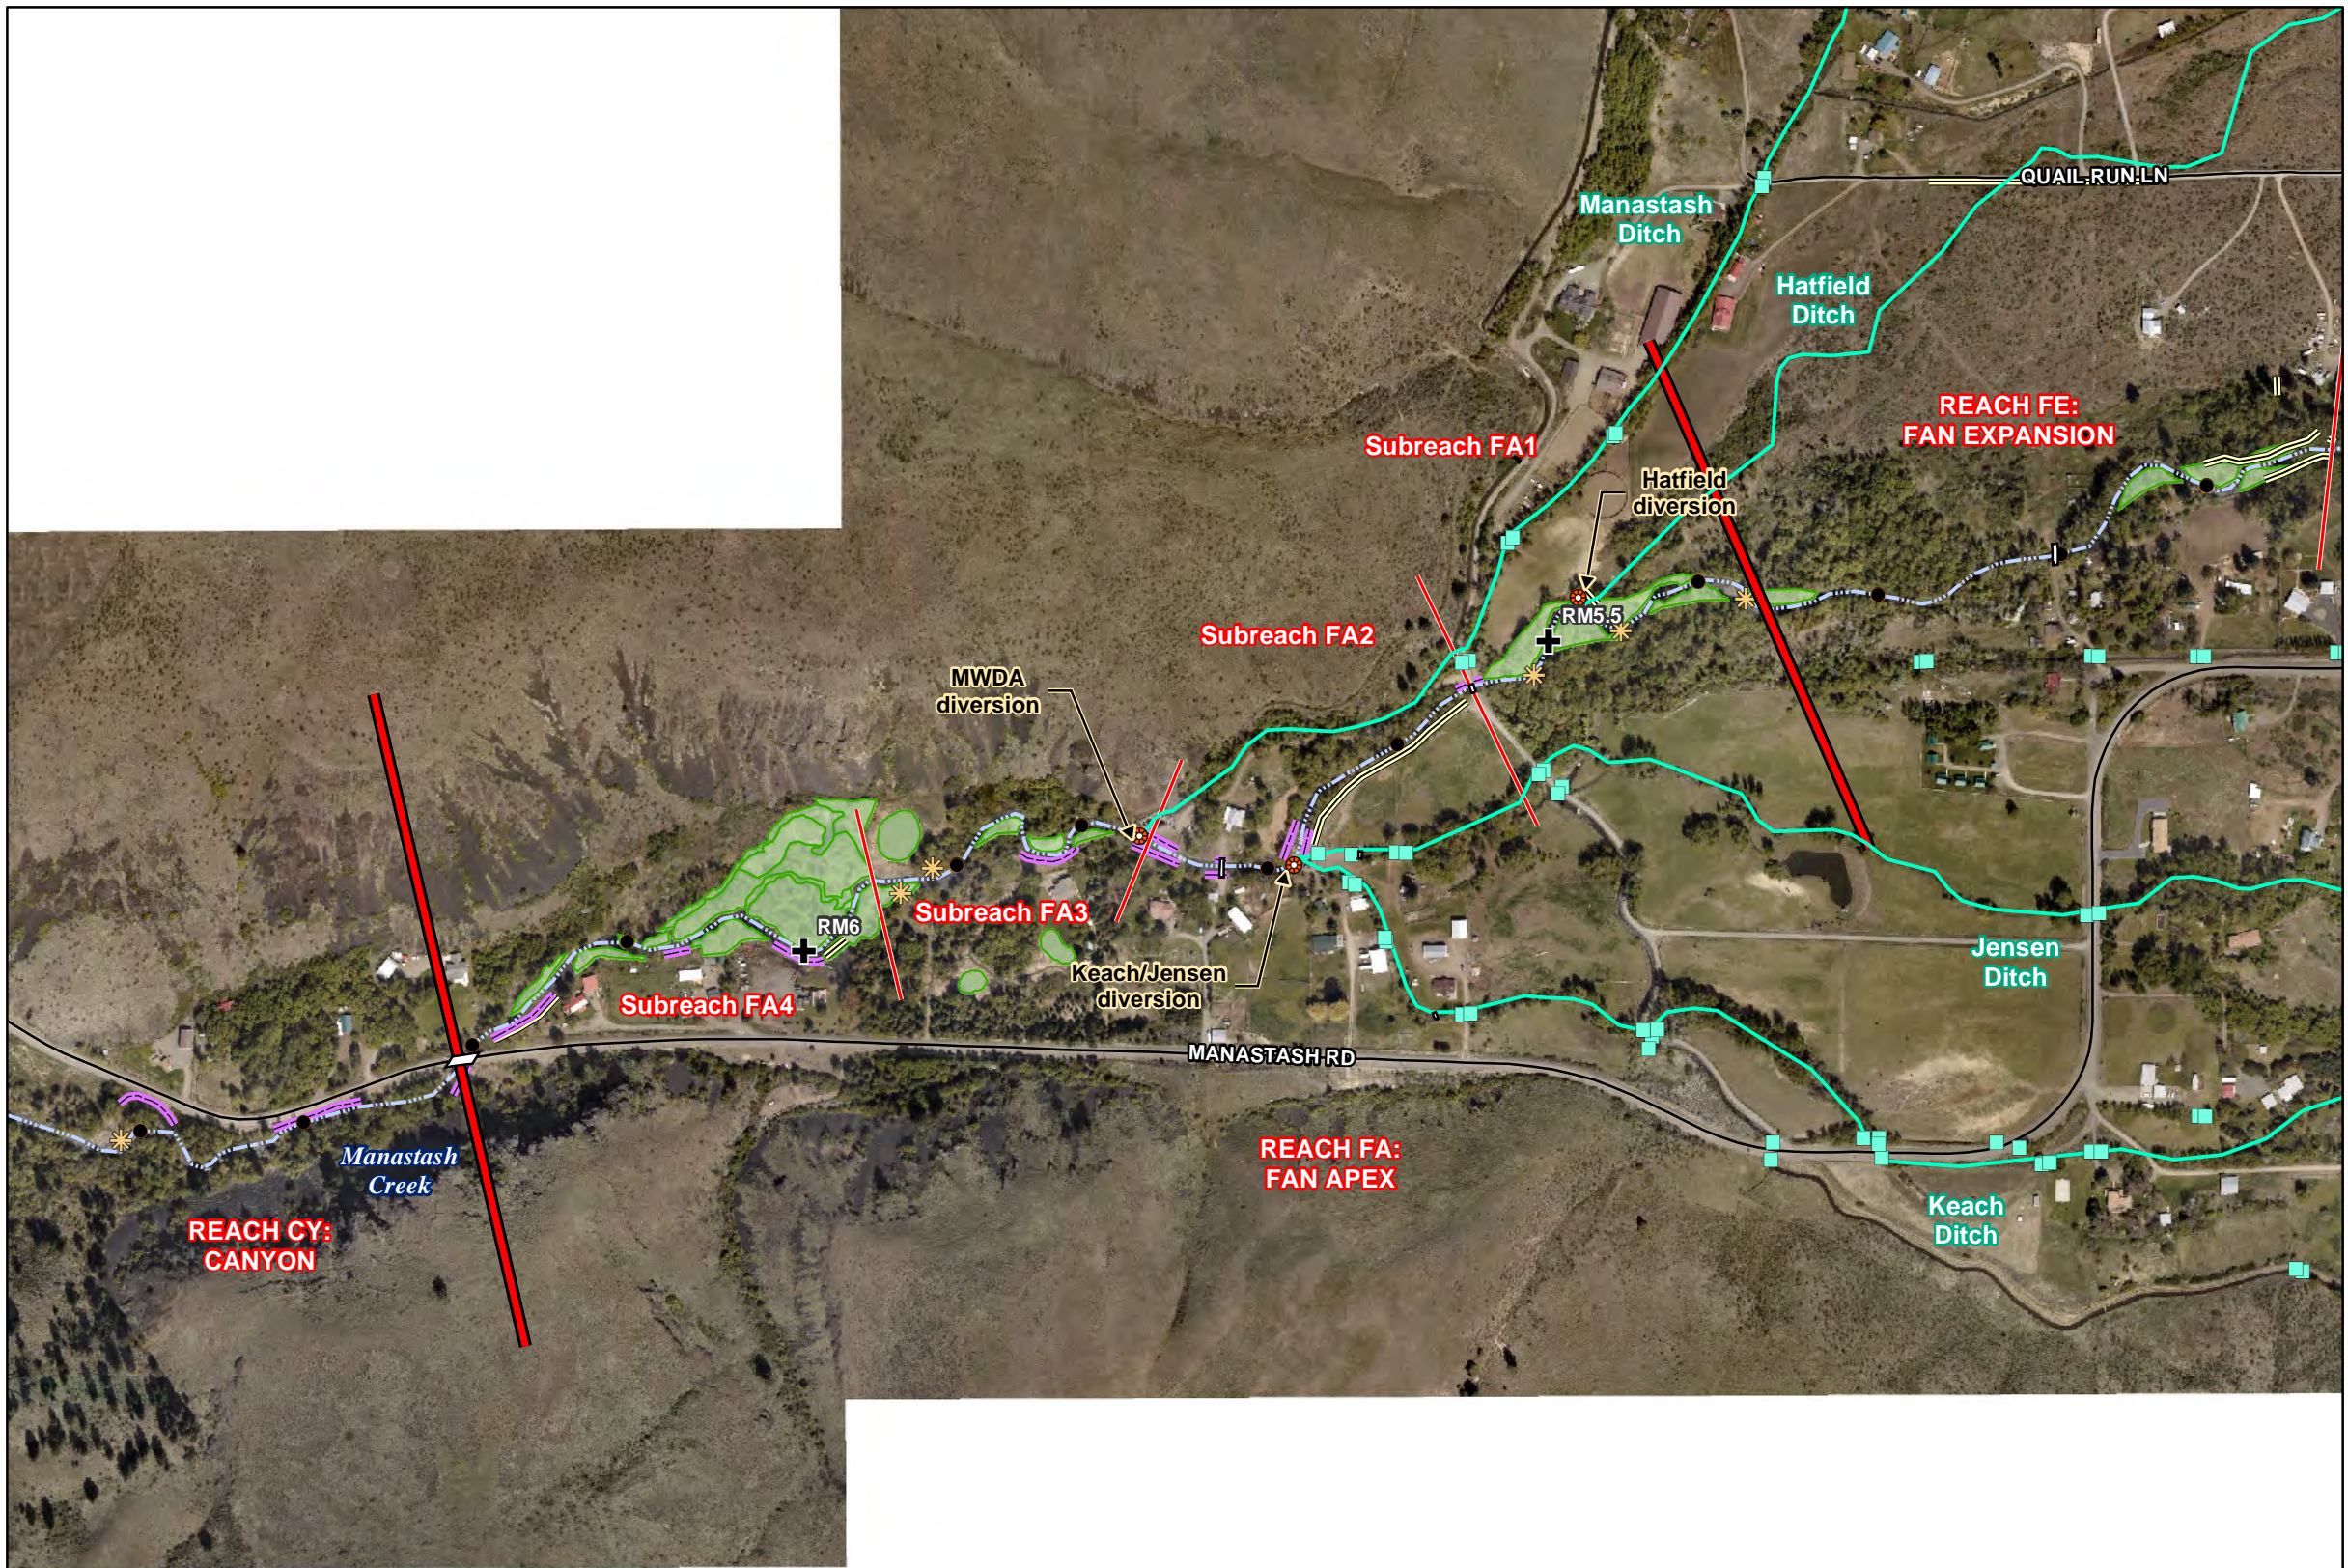
Figure A6.  
Fan Apex (Reach FA) habitat  
conditions.

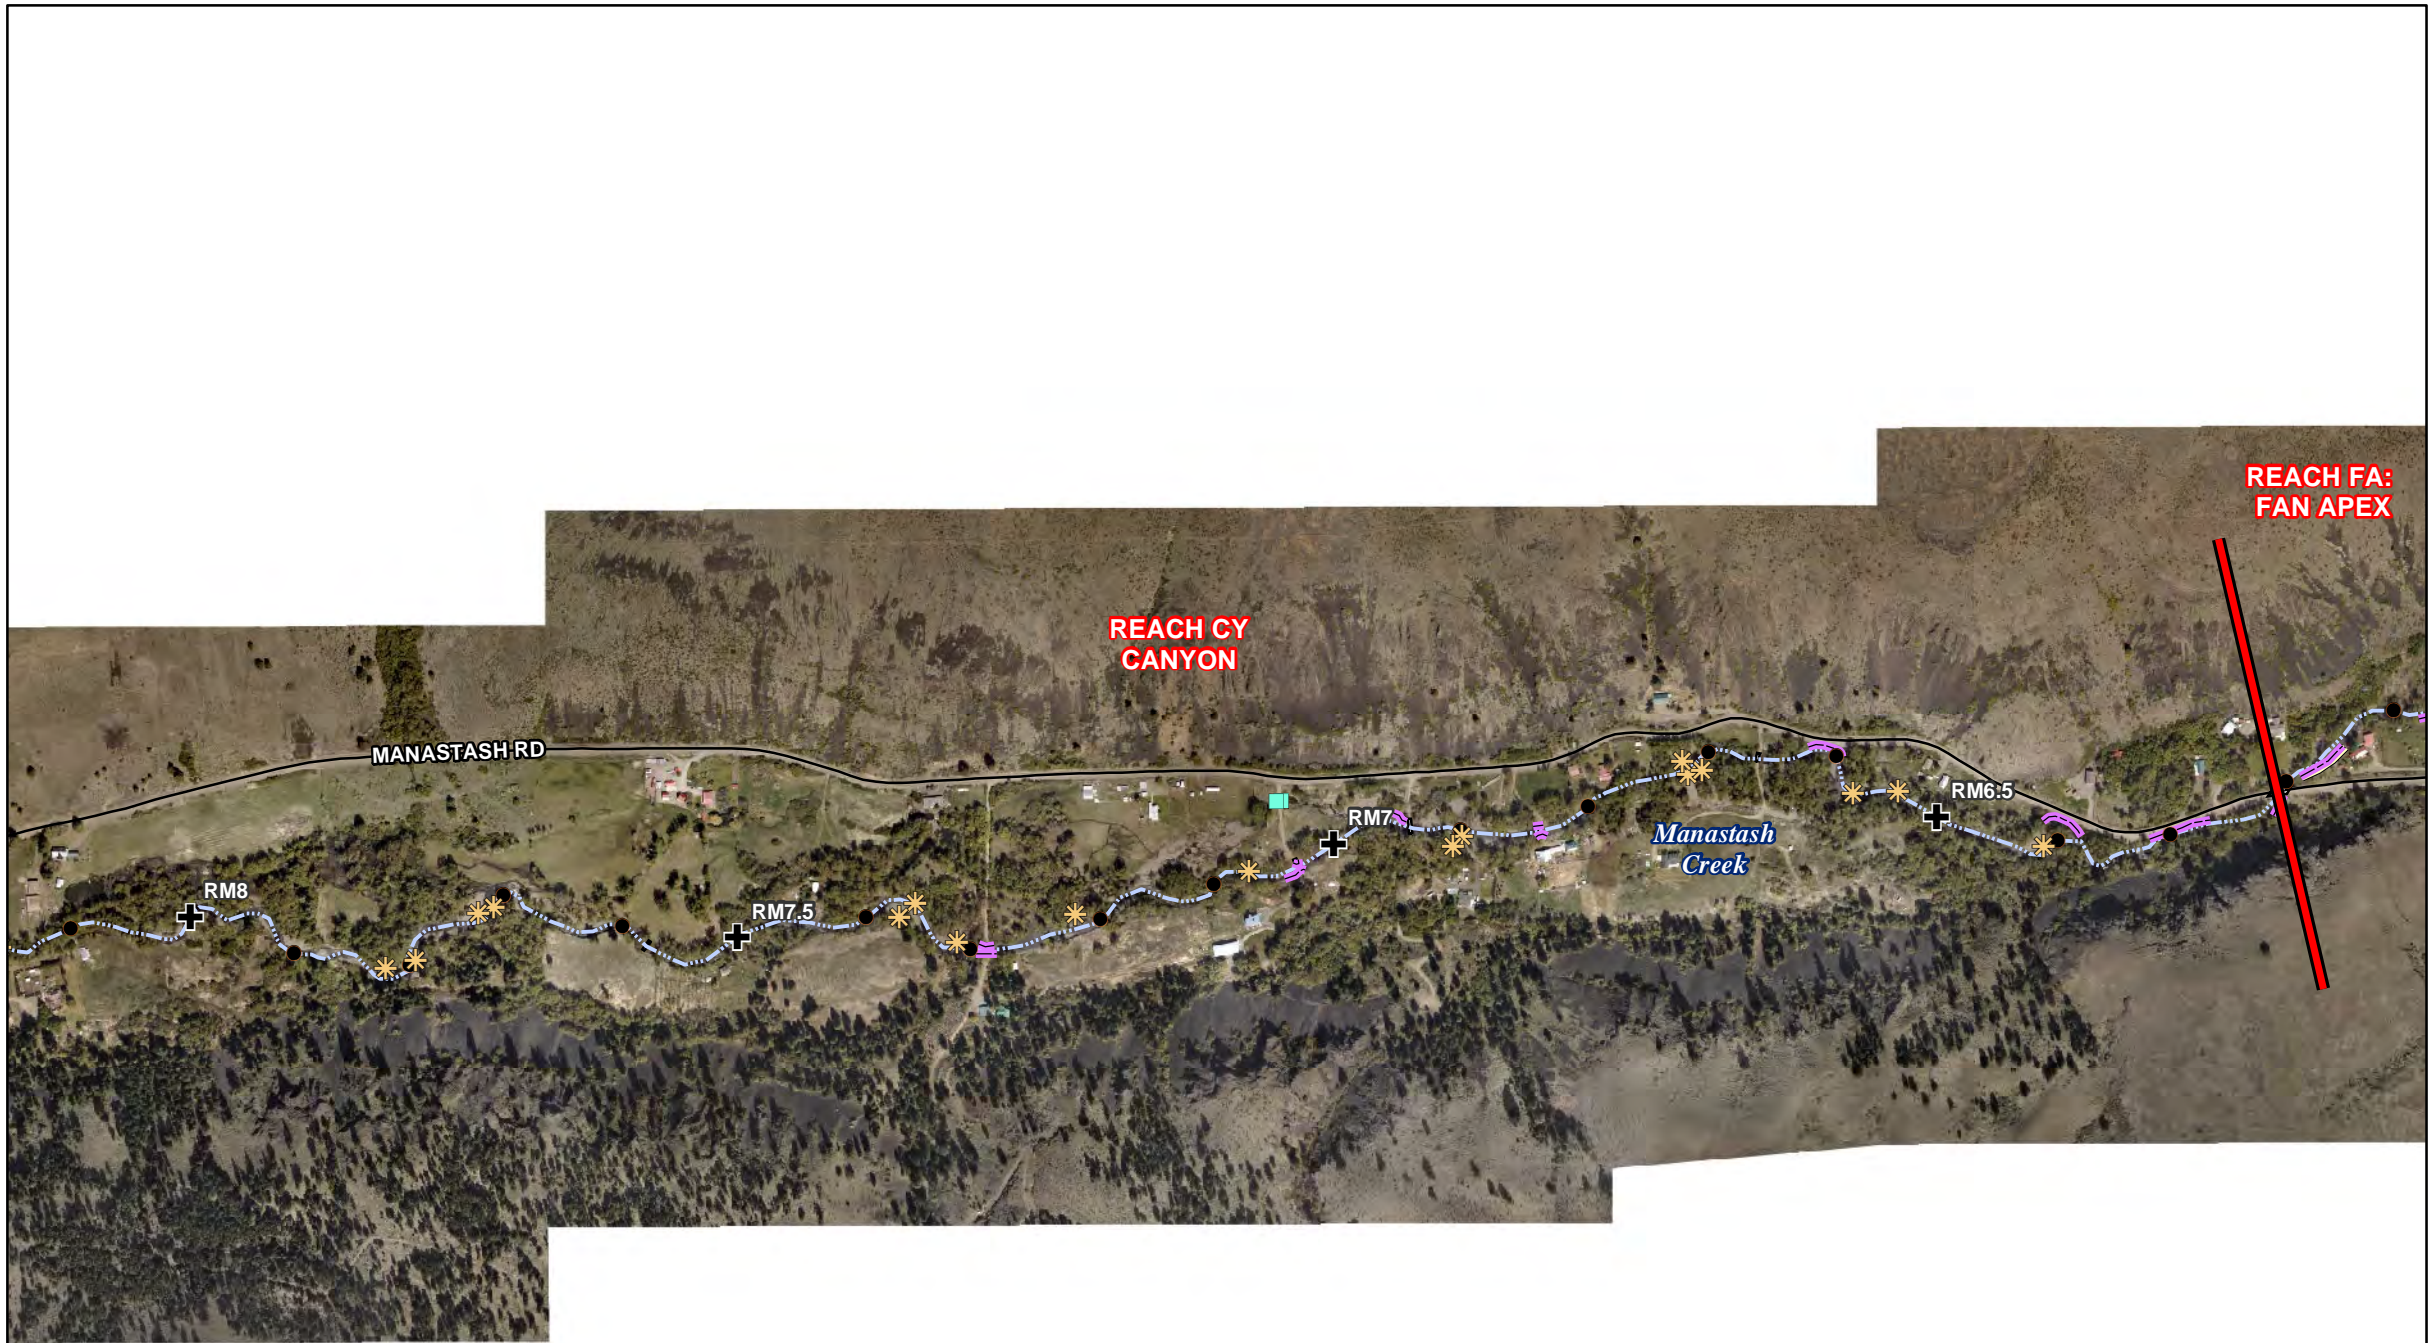
Figure A7.  
Canyon (Reach CY) habitat  
conditions (Sheet 1 of 4).
