## APPENDIX A

# Habitat Assessment Figures

## APPENDIX B

# Habitat Conditions Described by Reach-Based Ecosystem Indicators

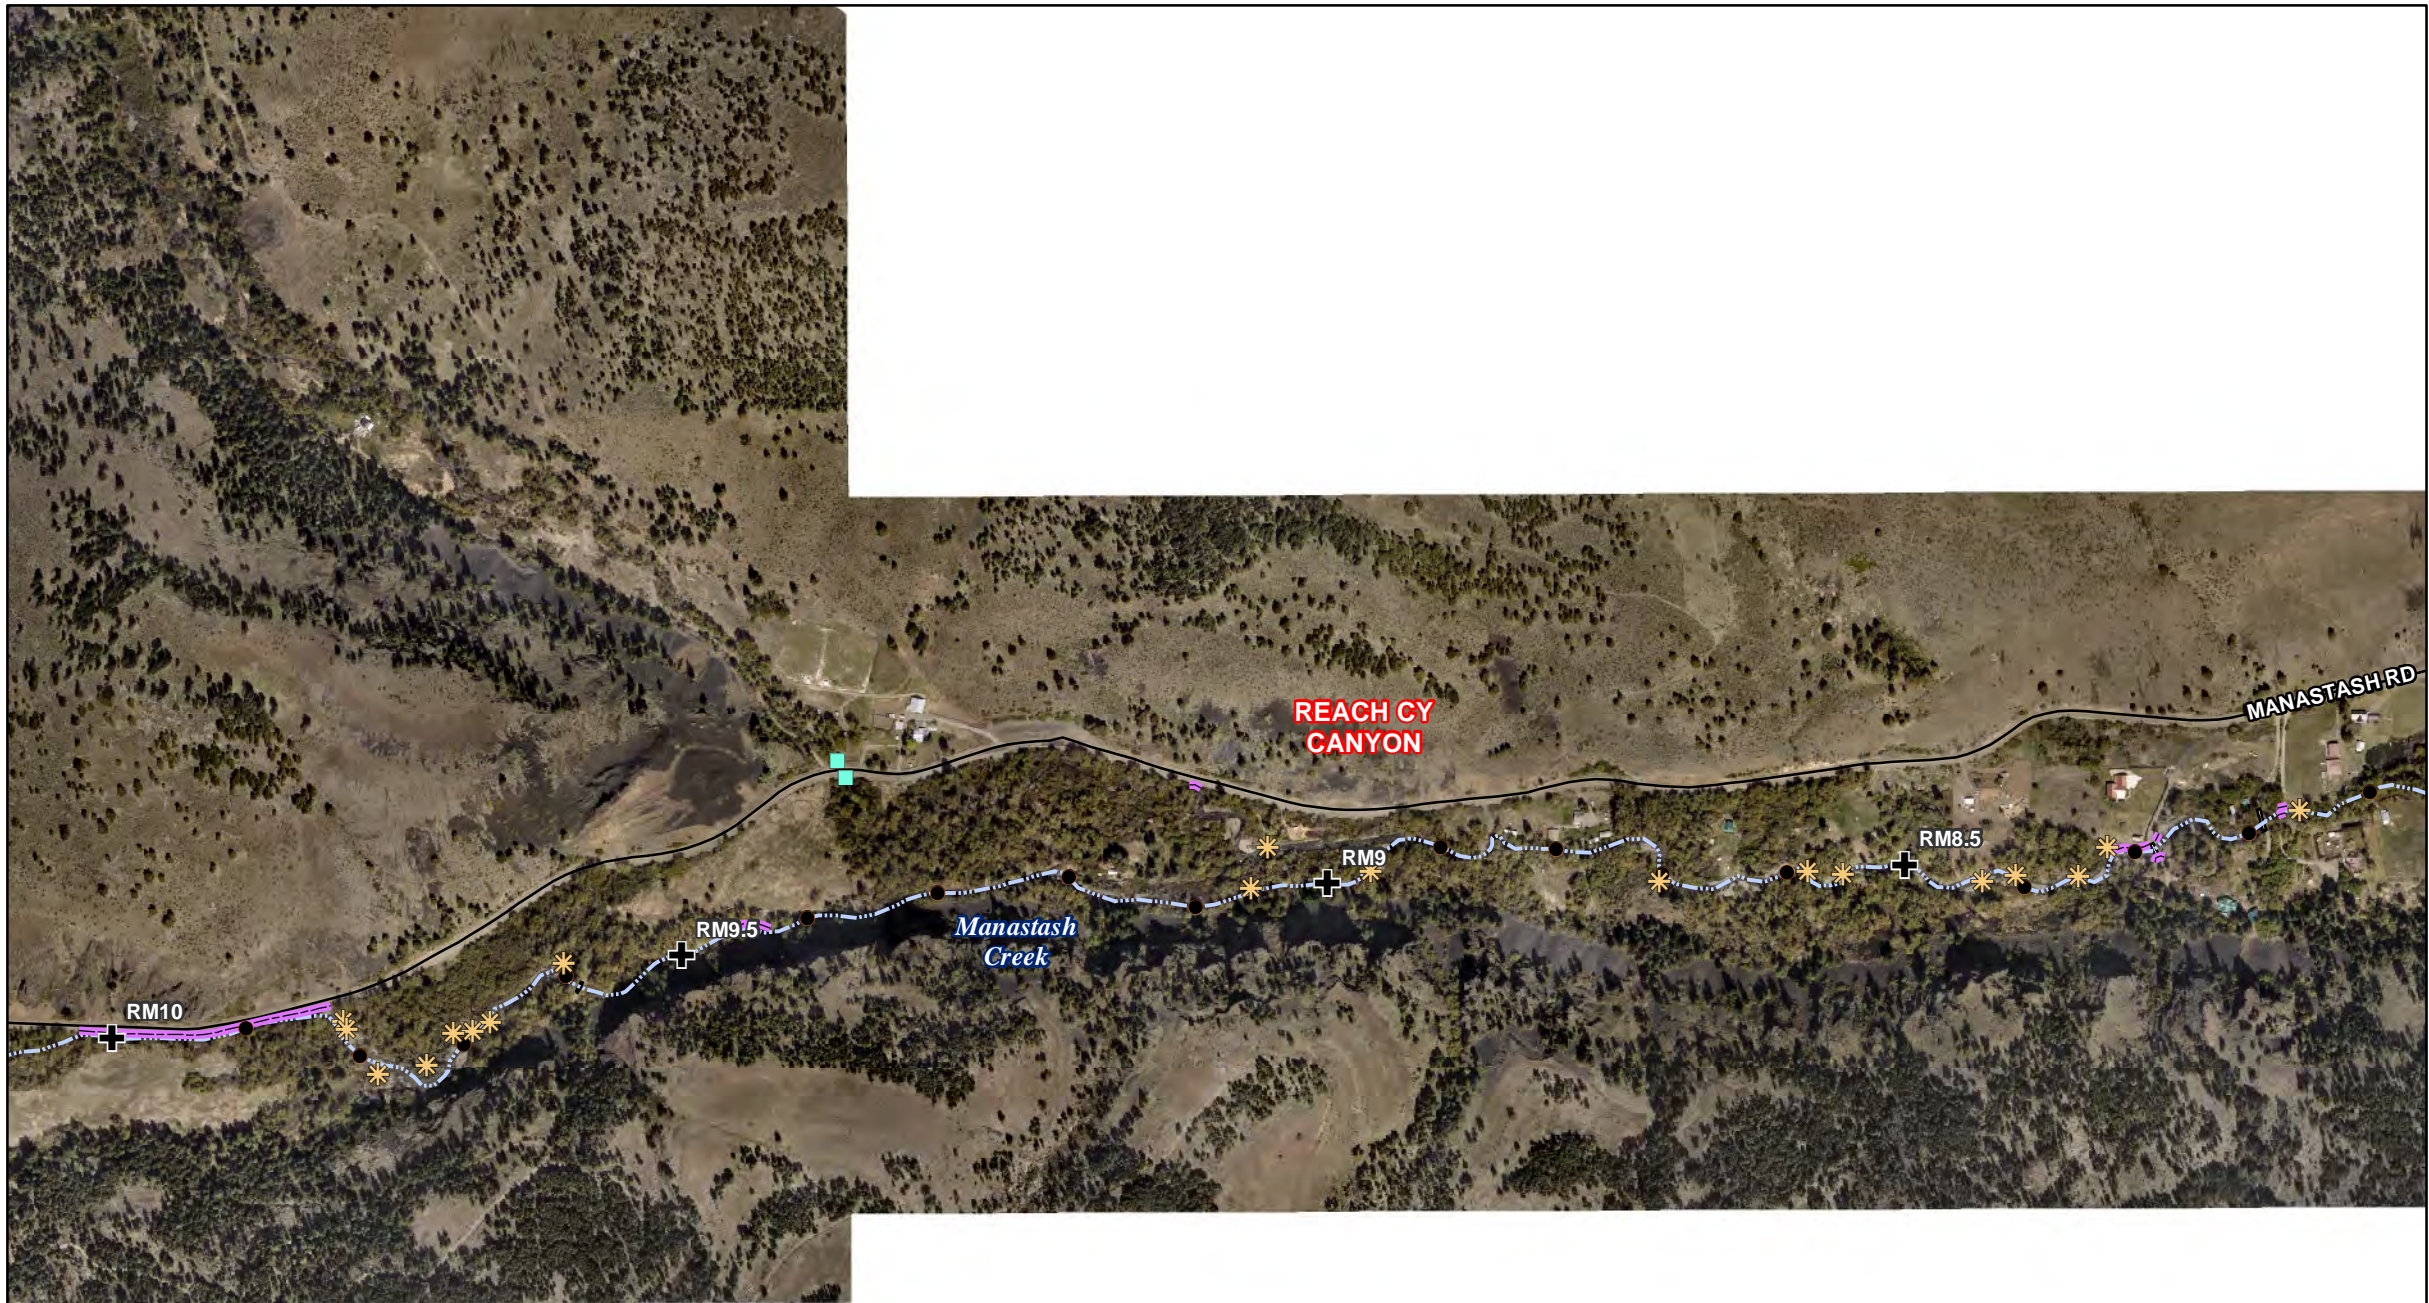
Figure A8.  
Canyon (Reach CY) habitat  
conditions (Sheet 2 of 4).

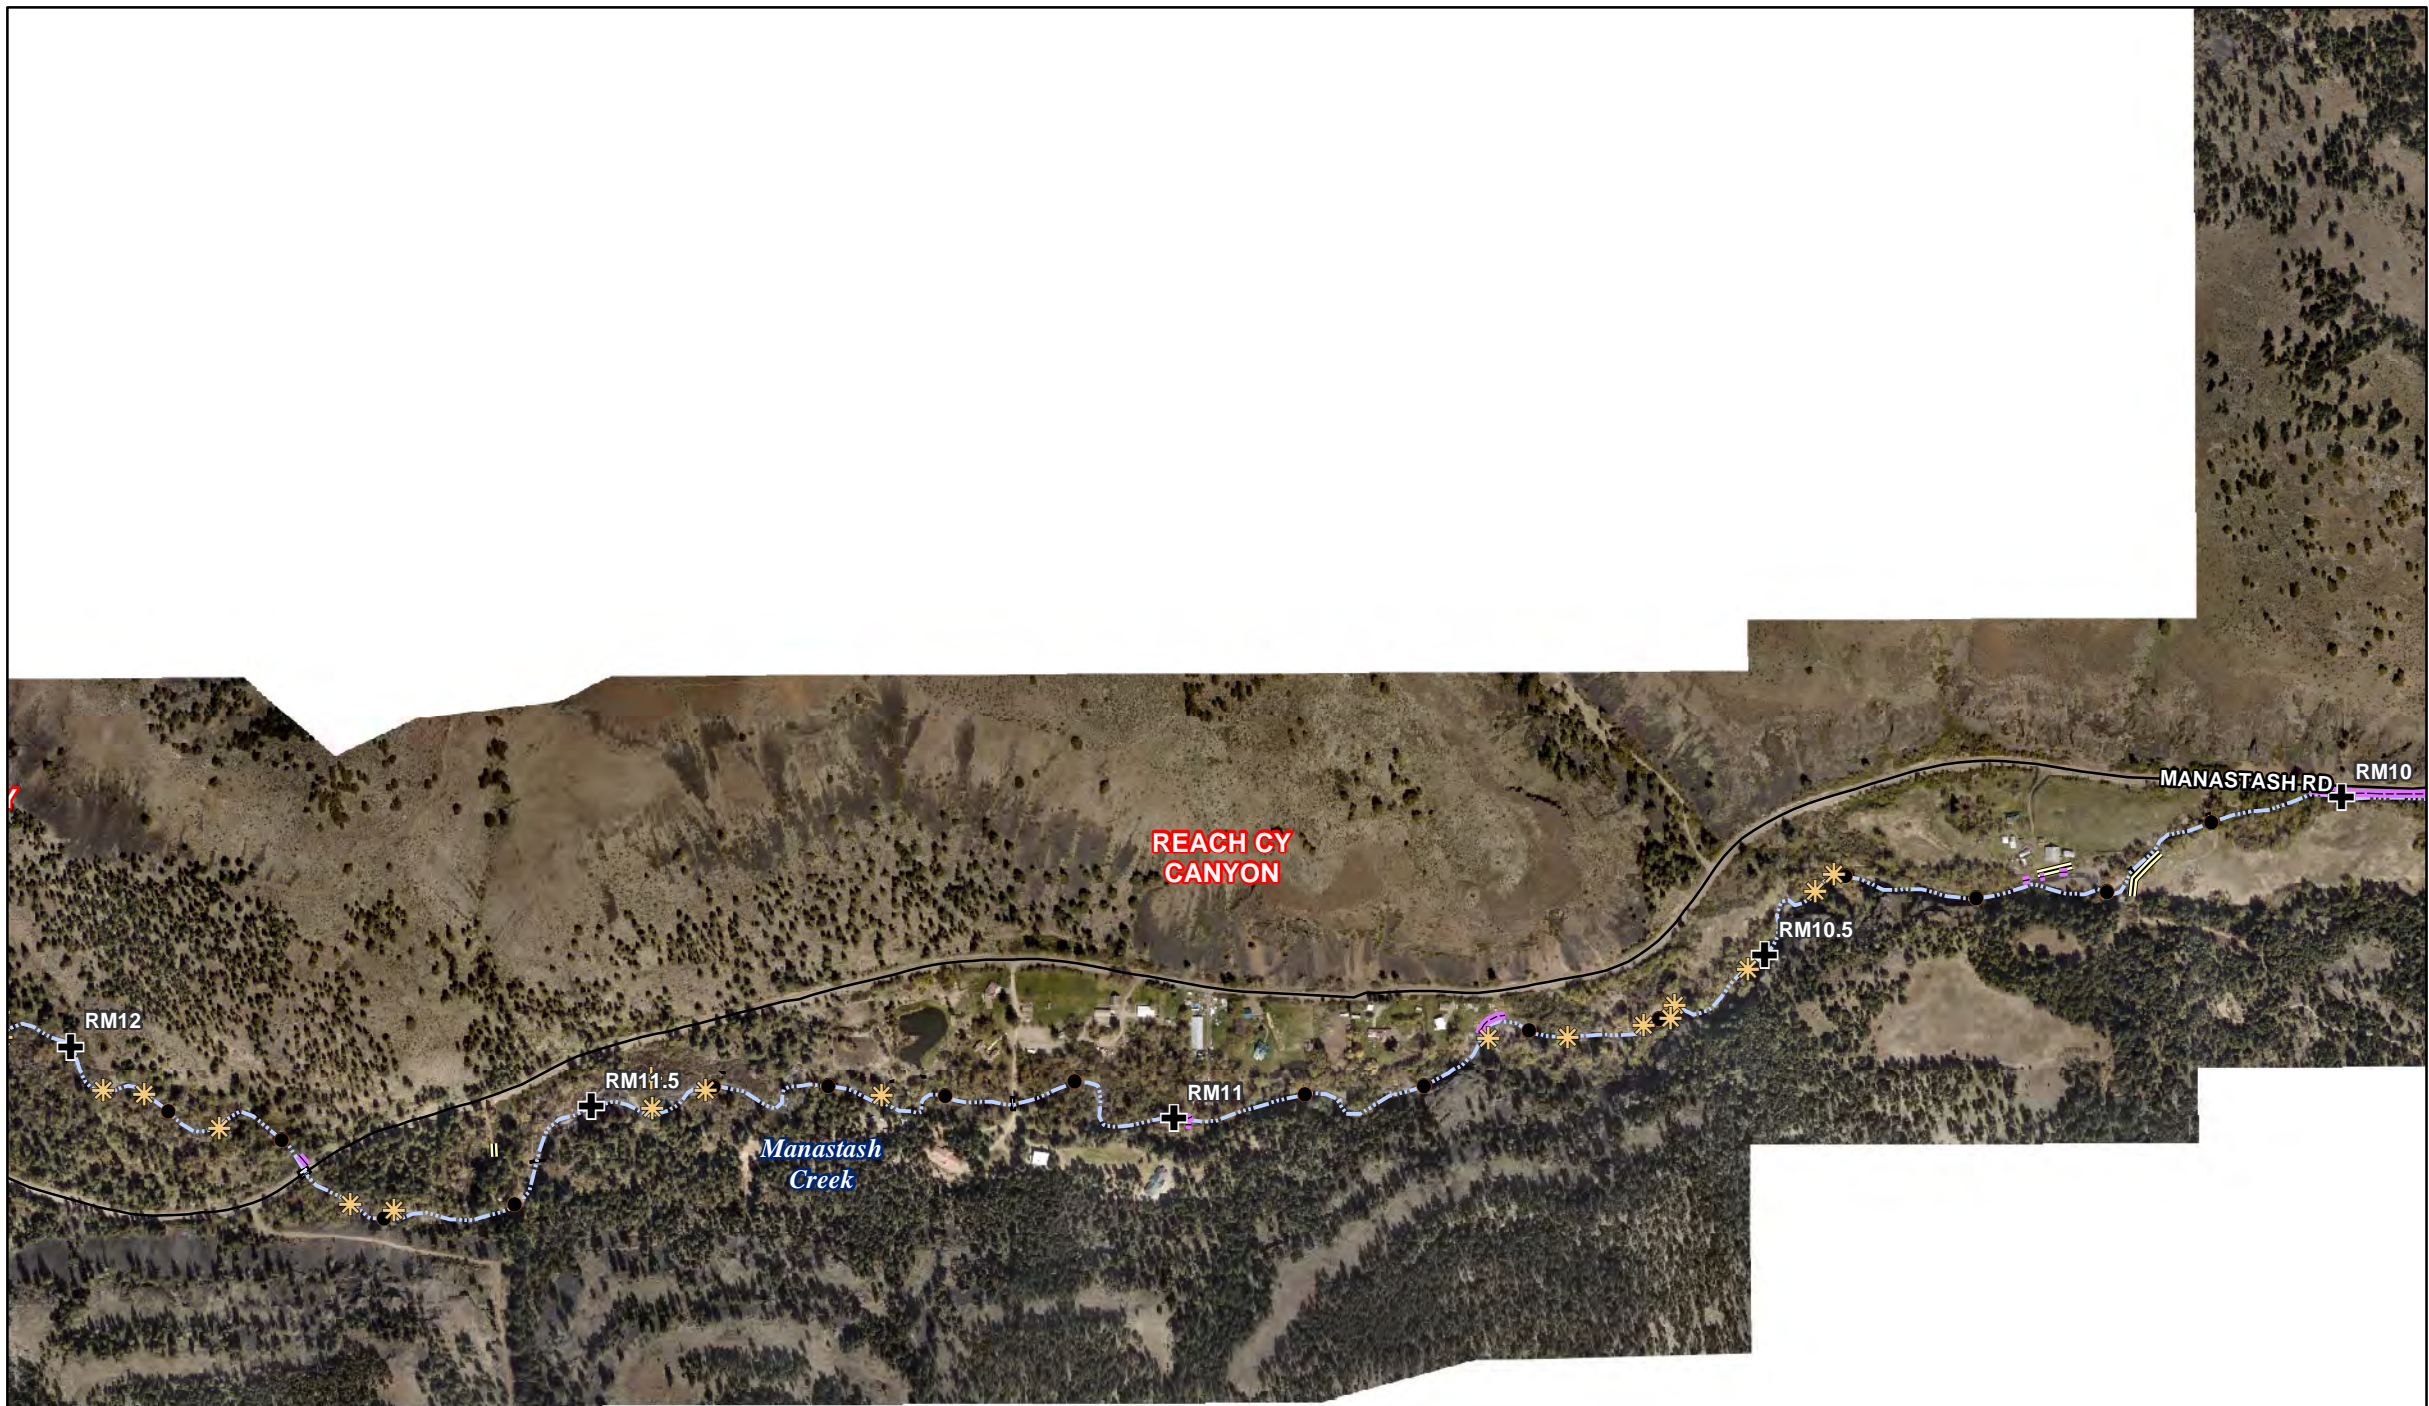
Figure A9.  
Canyon (Reach CY) habitat  
conditions (Sheet 3 of 4).

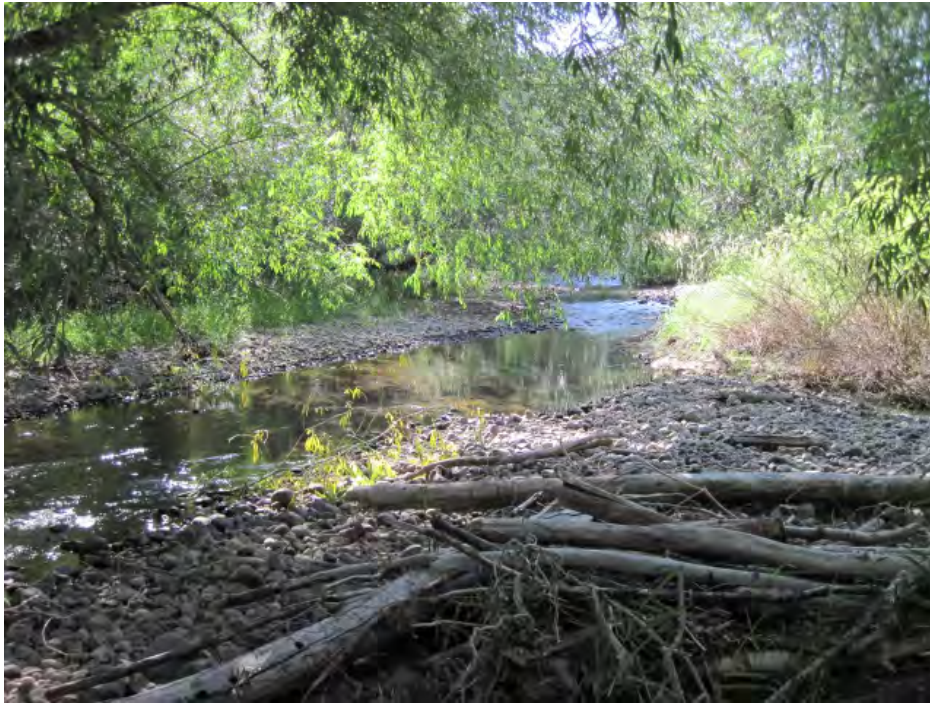
Photo D1. Stream channel and riparian habitat conditions in Reach YC.

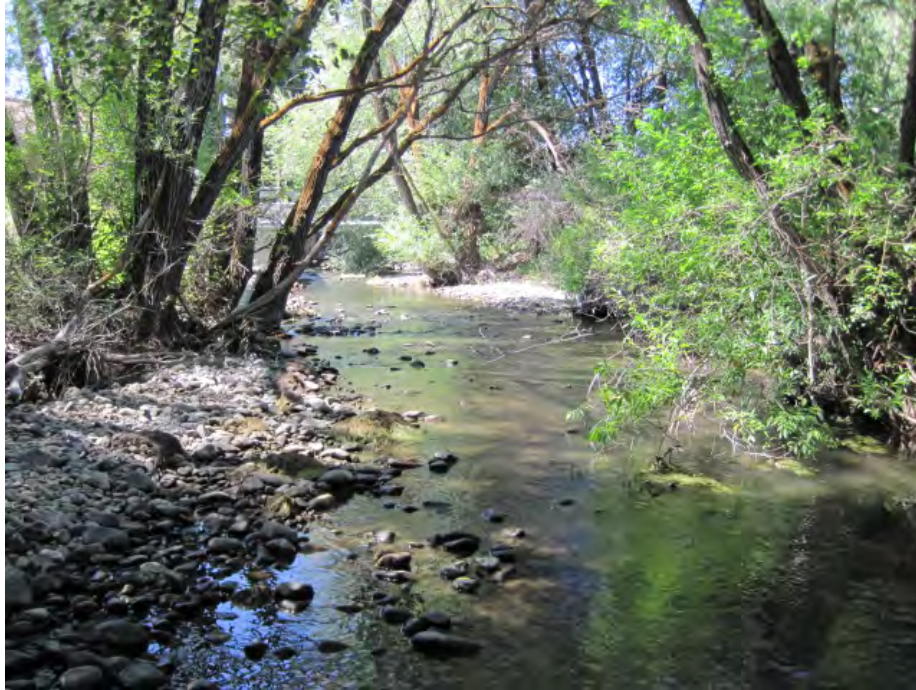
Photo D2. Stream channel and riparian habitat conditions in Reach BC1 downstream of Brown Road.

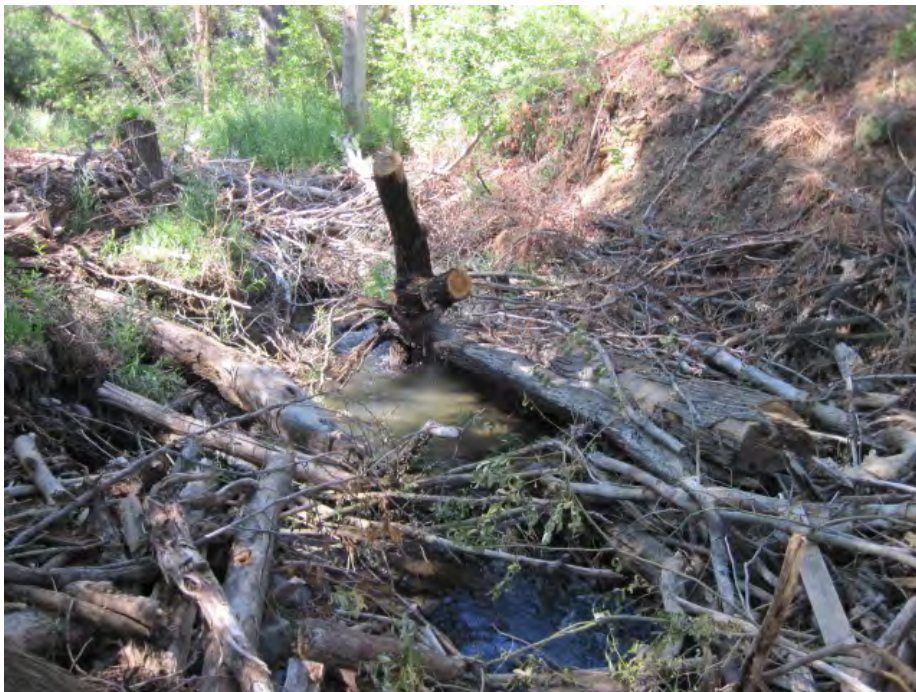
Photo D3. Large wood accumulation in Reach BC1.

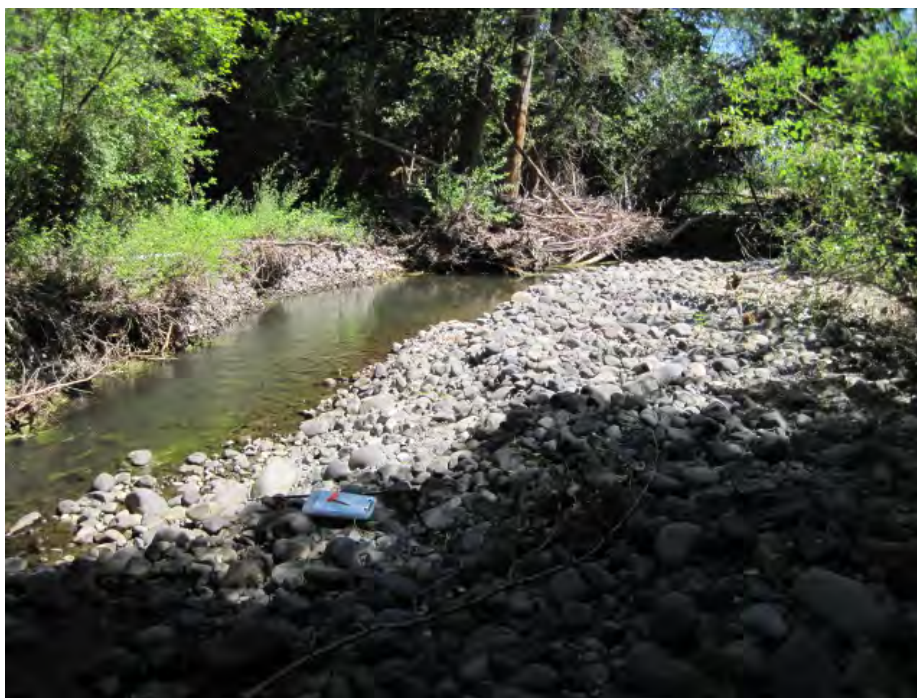
Photo D4. Algae growth in stream channel and riparian habitat conditions in Subreach BC3.

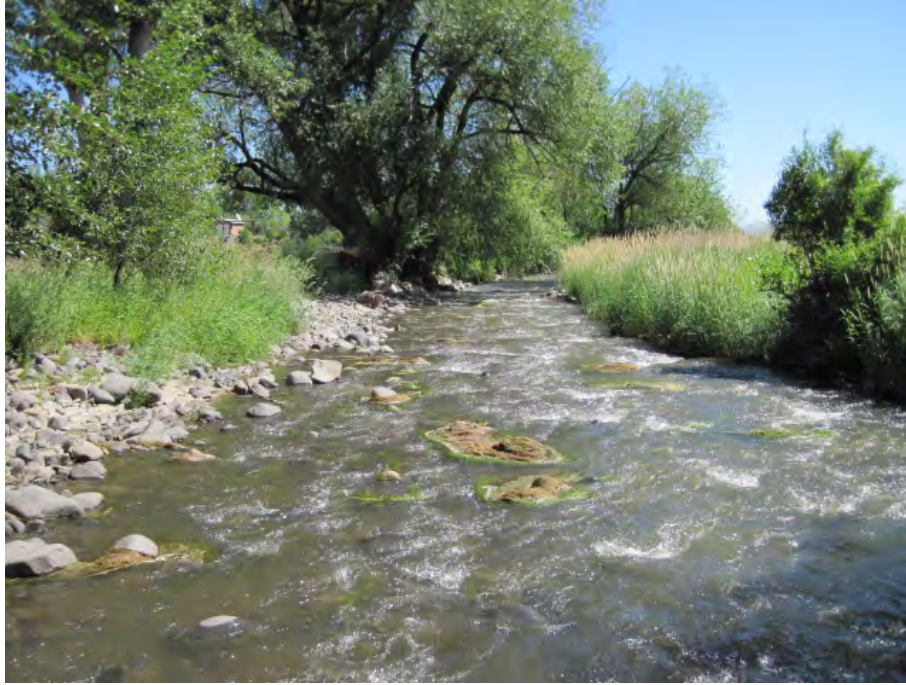
Photo D5. Turbid water and algae in stream channel in Subreach SC1.

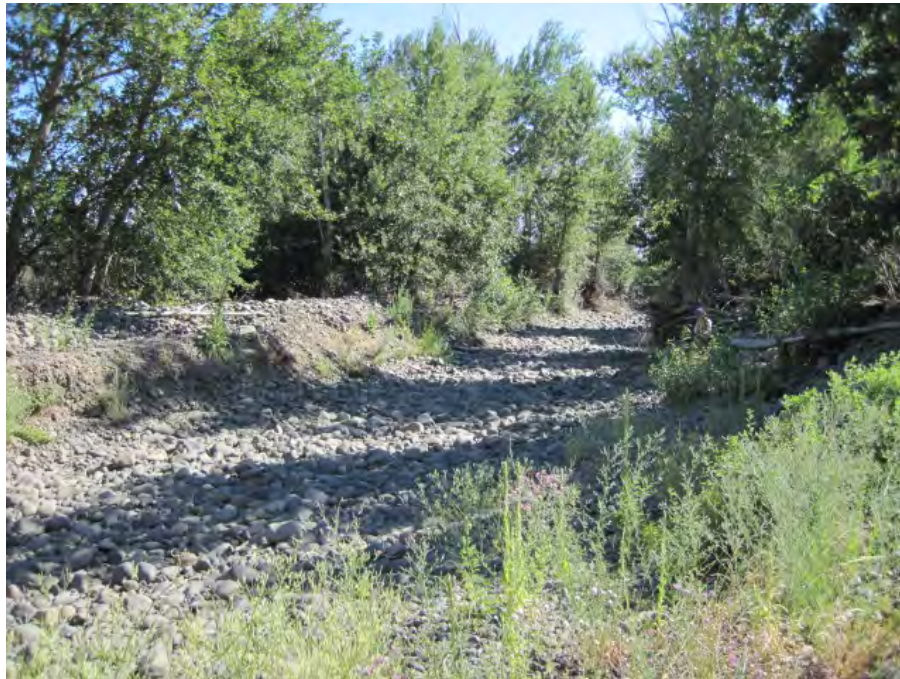
Photo D6. Dry stream channel conditions in Subreach SC2.

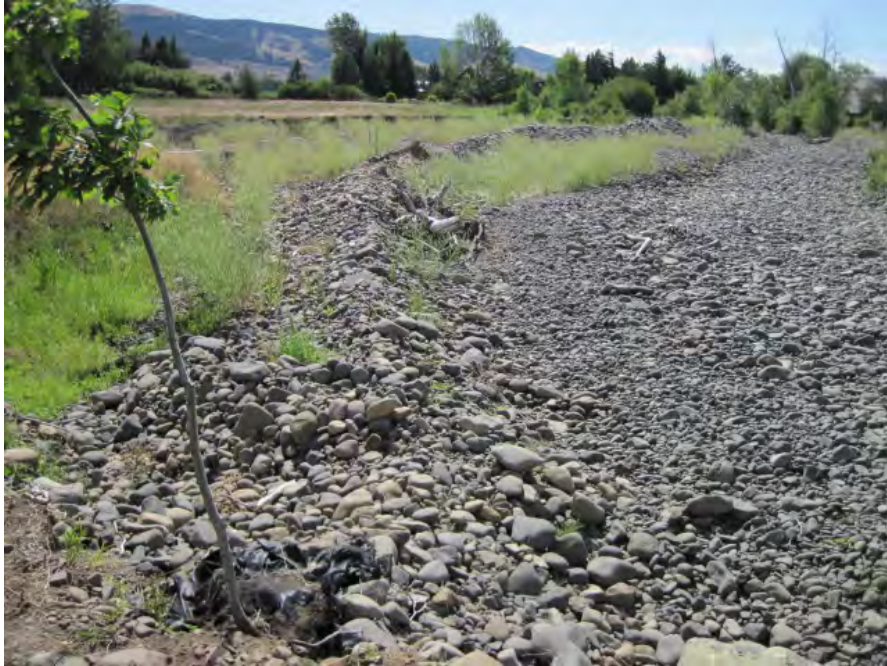
Photo D7. Dry stream channel, gravel berms, and unvegetated riparian conditions in Subreach FC1.

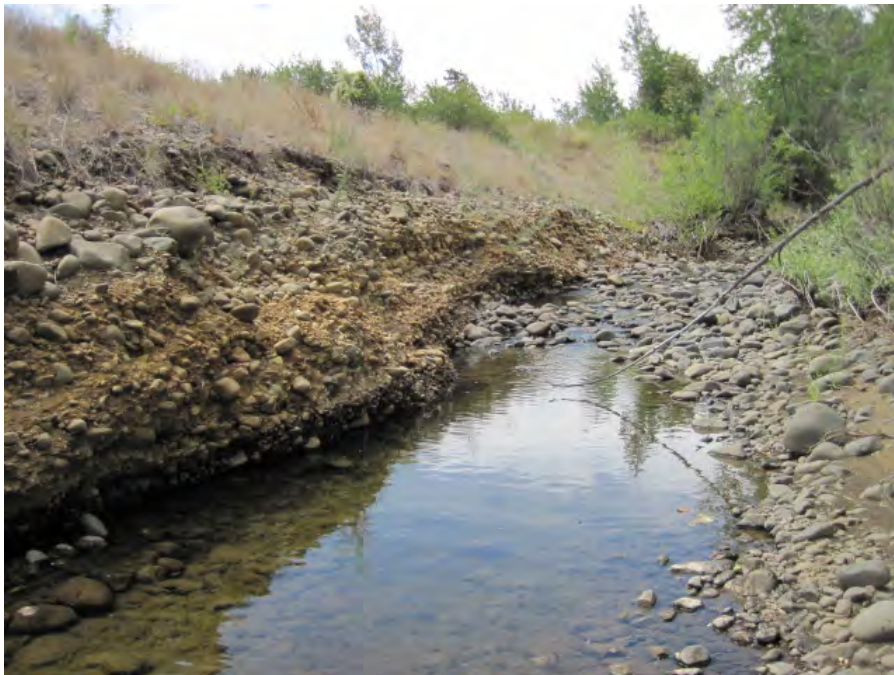
Photo D8. Groundwater fed base flow within confined stream channel in Subreach FC2.

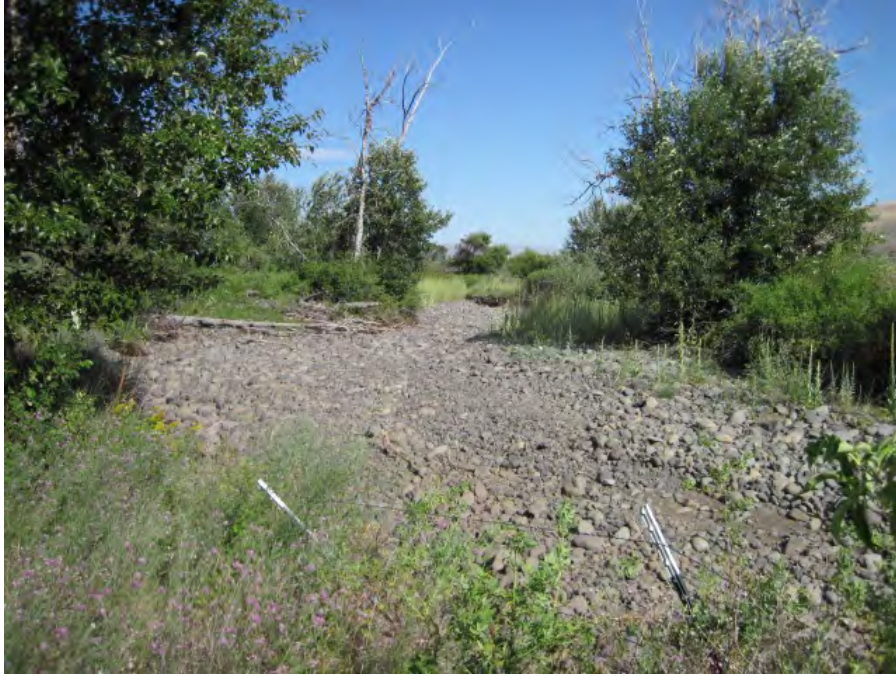
Photo D9. Dry stream channel and riparian habitat conditions in Subreach FC4.

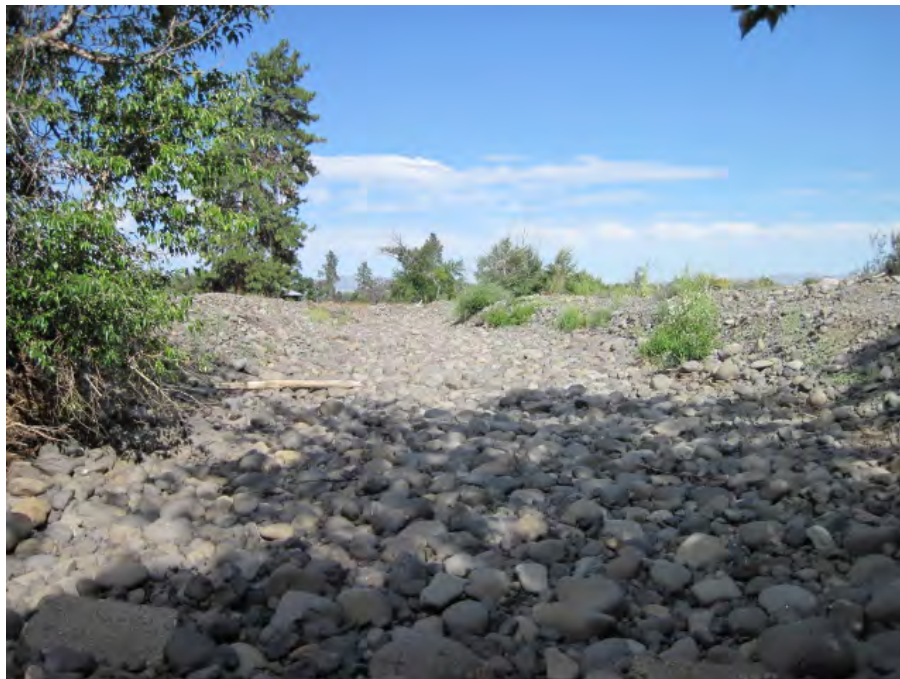
Photo D10. Dry stream channel and riparian habitat conditions in Subreach FC5.

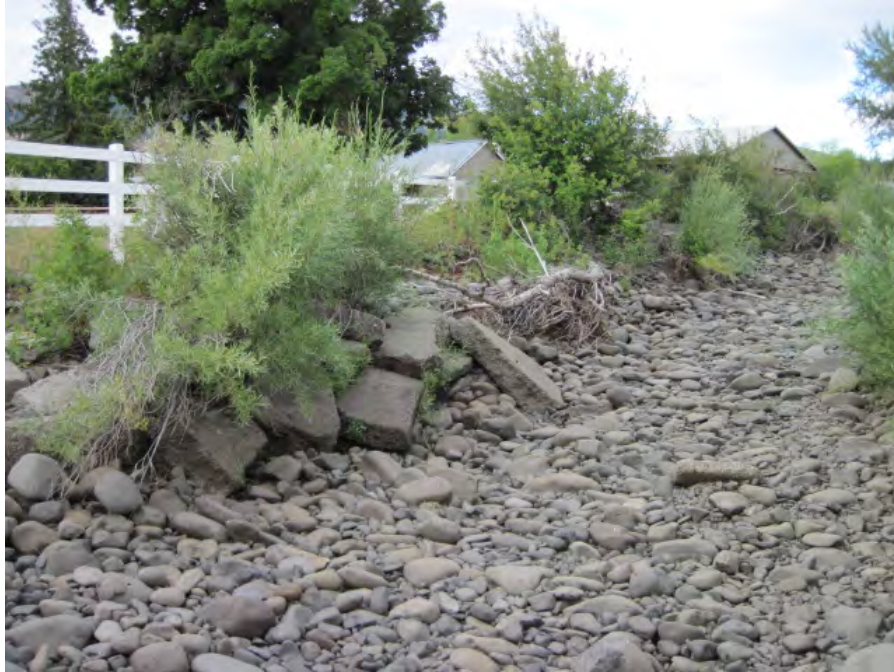
Photo D11. Dry stream channel and berm/revetment upstream of Cove Road in Subreach FE1.

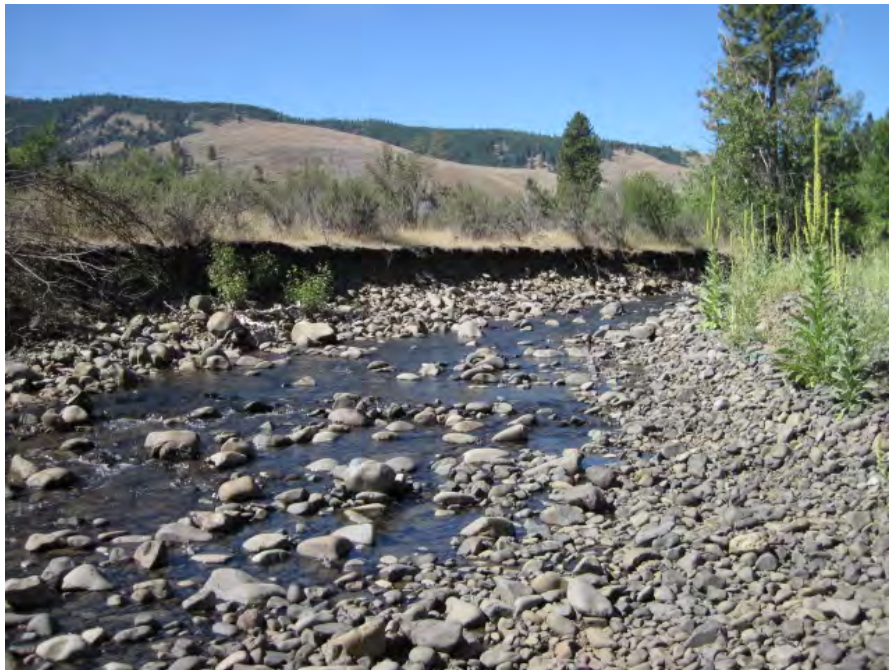
Photo D12. Stream channel and riparian habitat conditions in Subreach FE2.

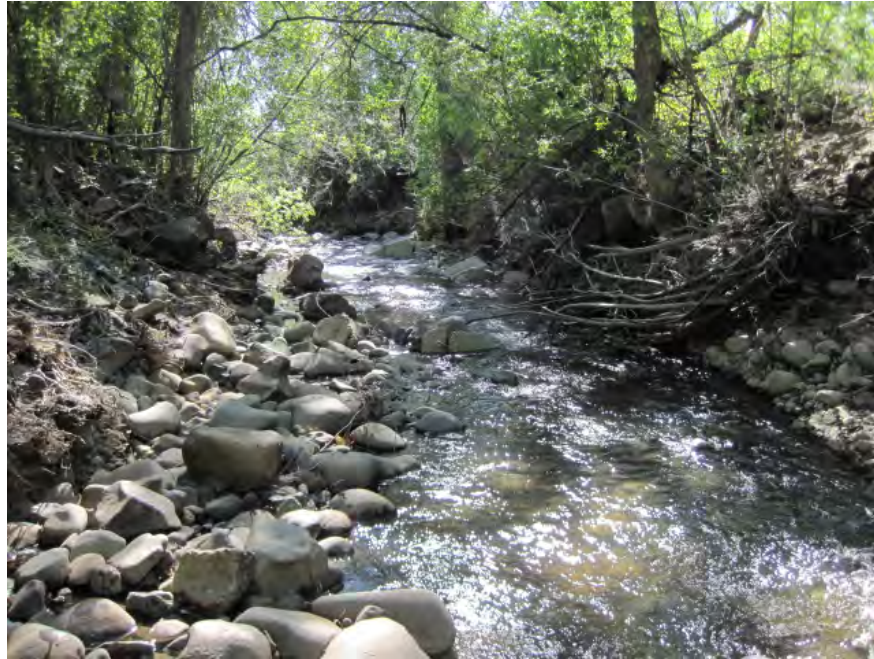
Photo D13. Entrenched stream channel and riparian habitat conditions downstream of Reed diversion in Subreach FE3.

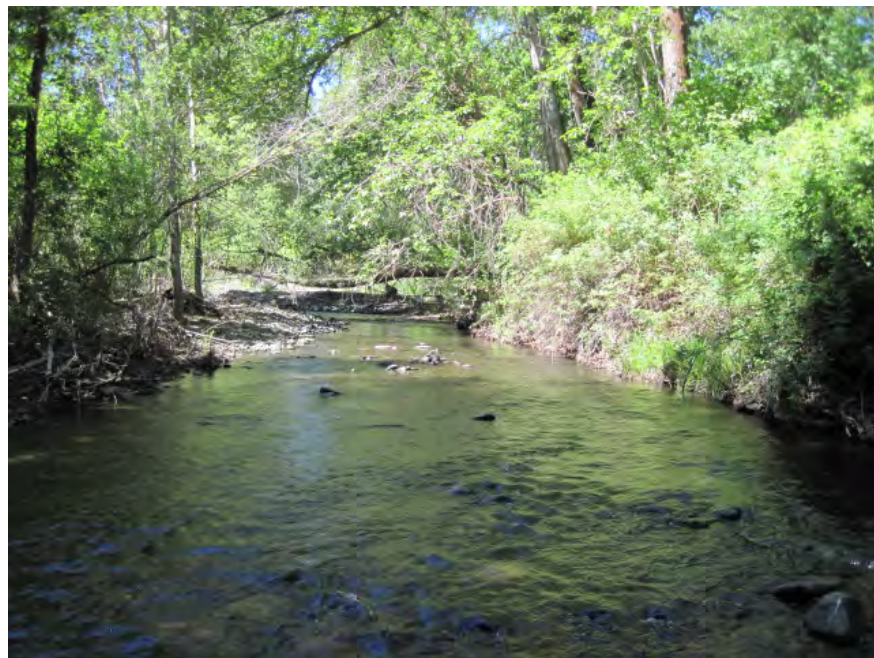
Photo D14. Stream channel and riparian habitat conditions in Subreach FE4.

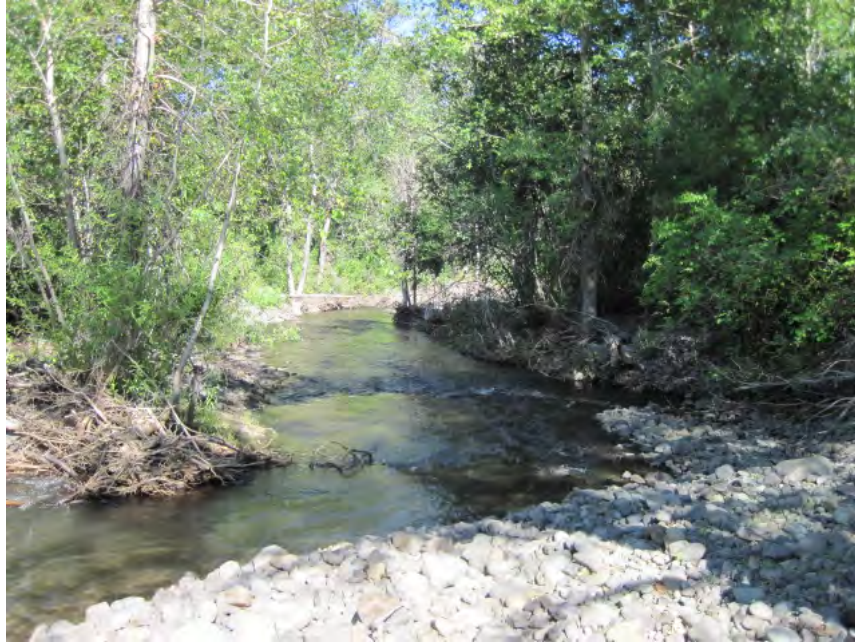
Photo D15. Stream channel and riparian habitat conditions in Subreach FA1.

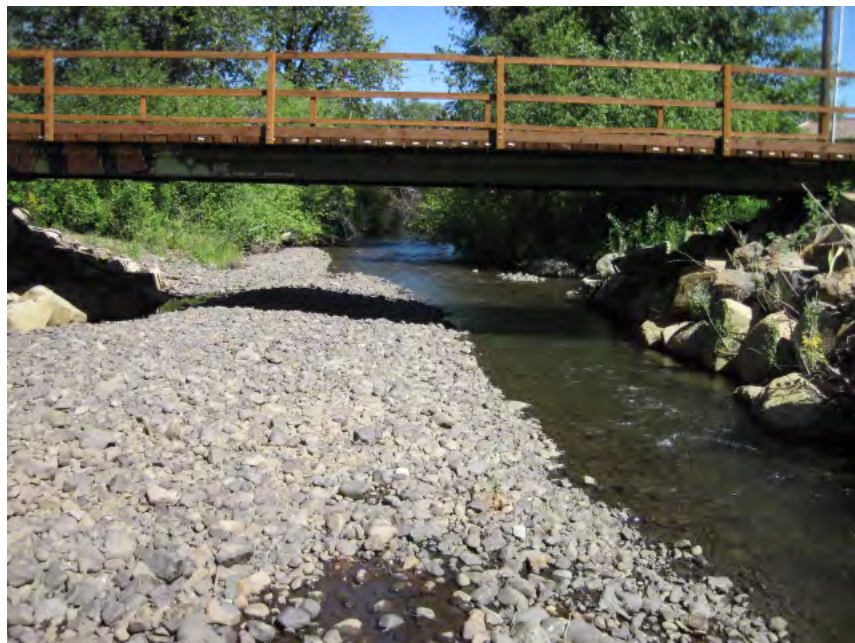
Photo D16. Stream channel and bridge in Subreach FA2.

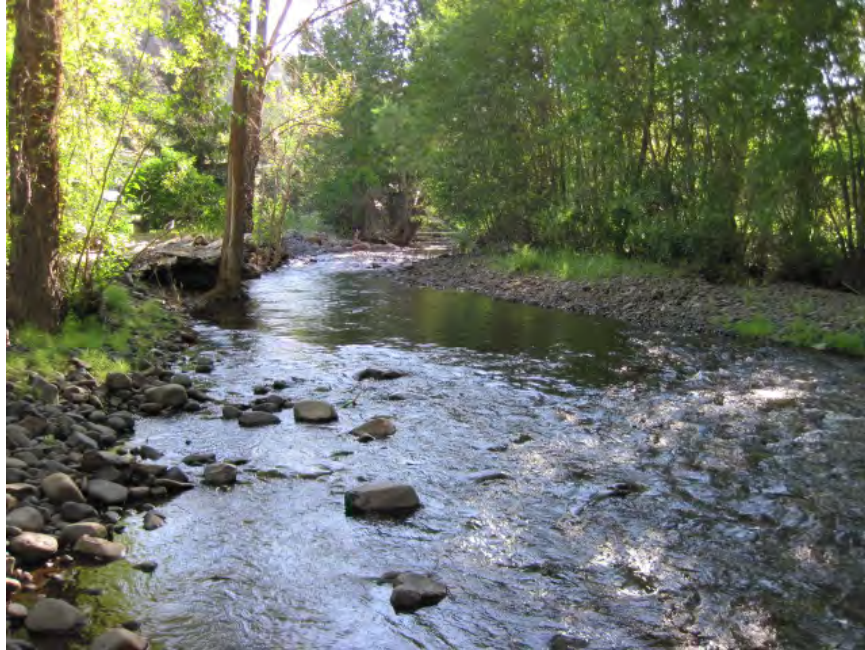
Photo D17. Stream channel and riparian habitat conditions in Subreach FA4.

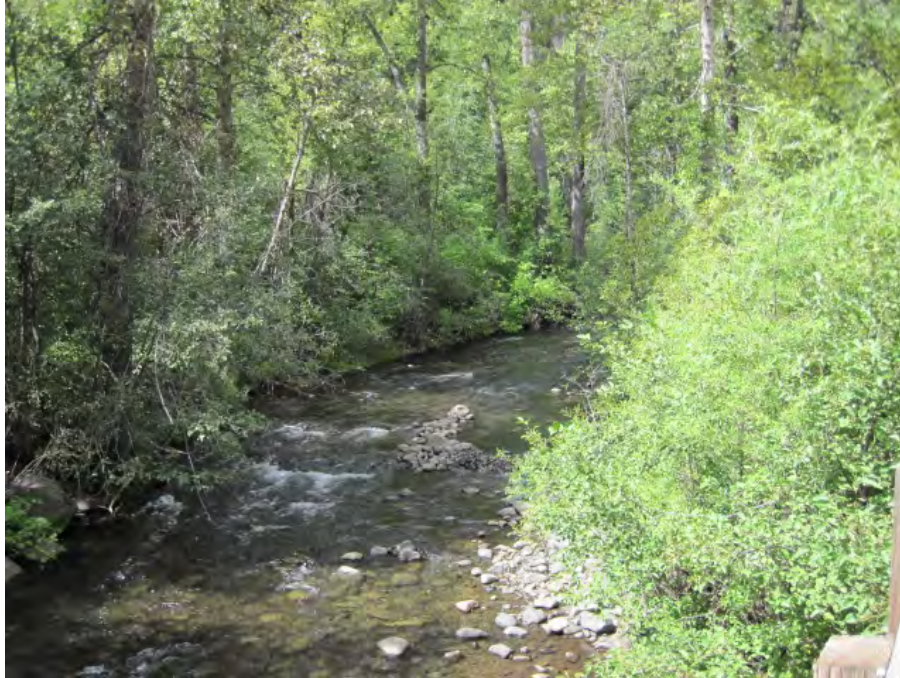
Photo D18. Stream channel and riparian habitat conditions in Reach CY.

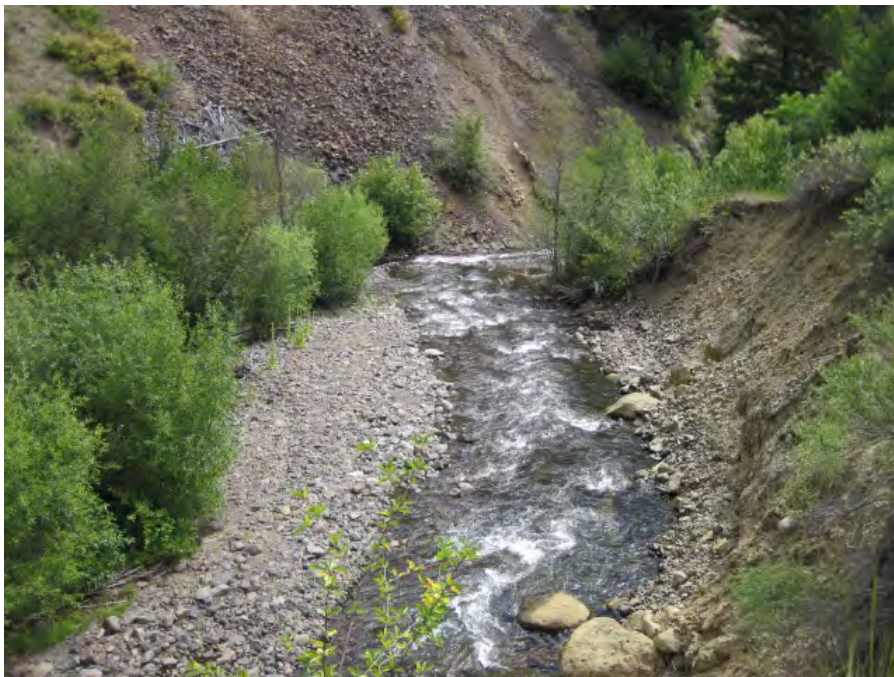
Photo D19. Stream channel and riparian habitat conditions in Reach CY.

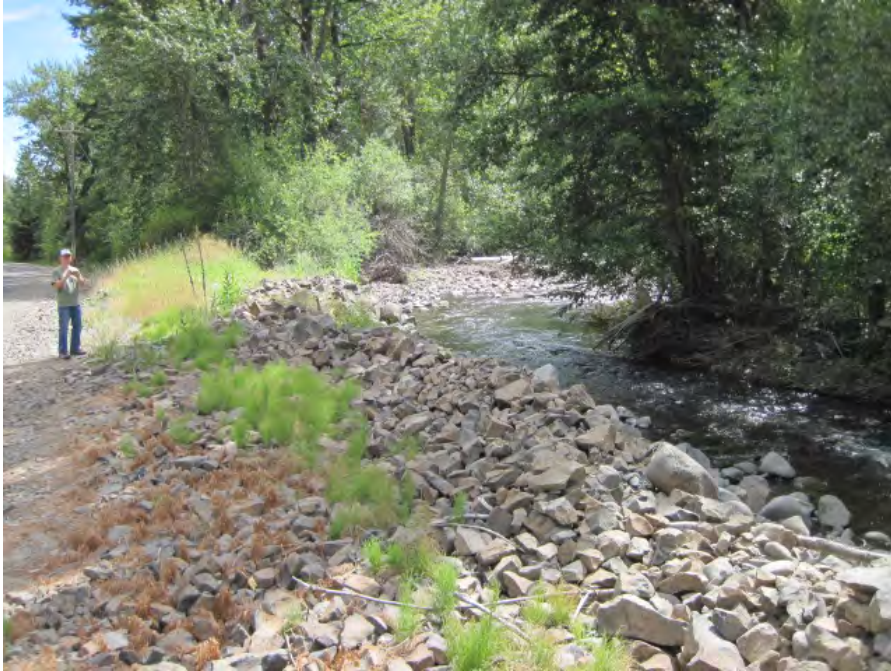
Photo D20. Gravel berm along Manastash Road in Reach CY.
