MANASTASH CREEK CORRIDOR HABITAT ENHANCEMENT AND FLOOD HAZARD REDUCTION PLAN

Prepared for
Kittitas County Conservation District

Prepared by
Herrera Environmental Consultants, Inc.
and
Watershed Science & Engineering, Inc.

June 12, 2013

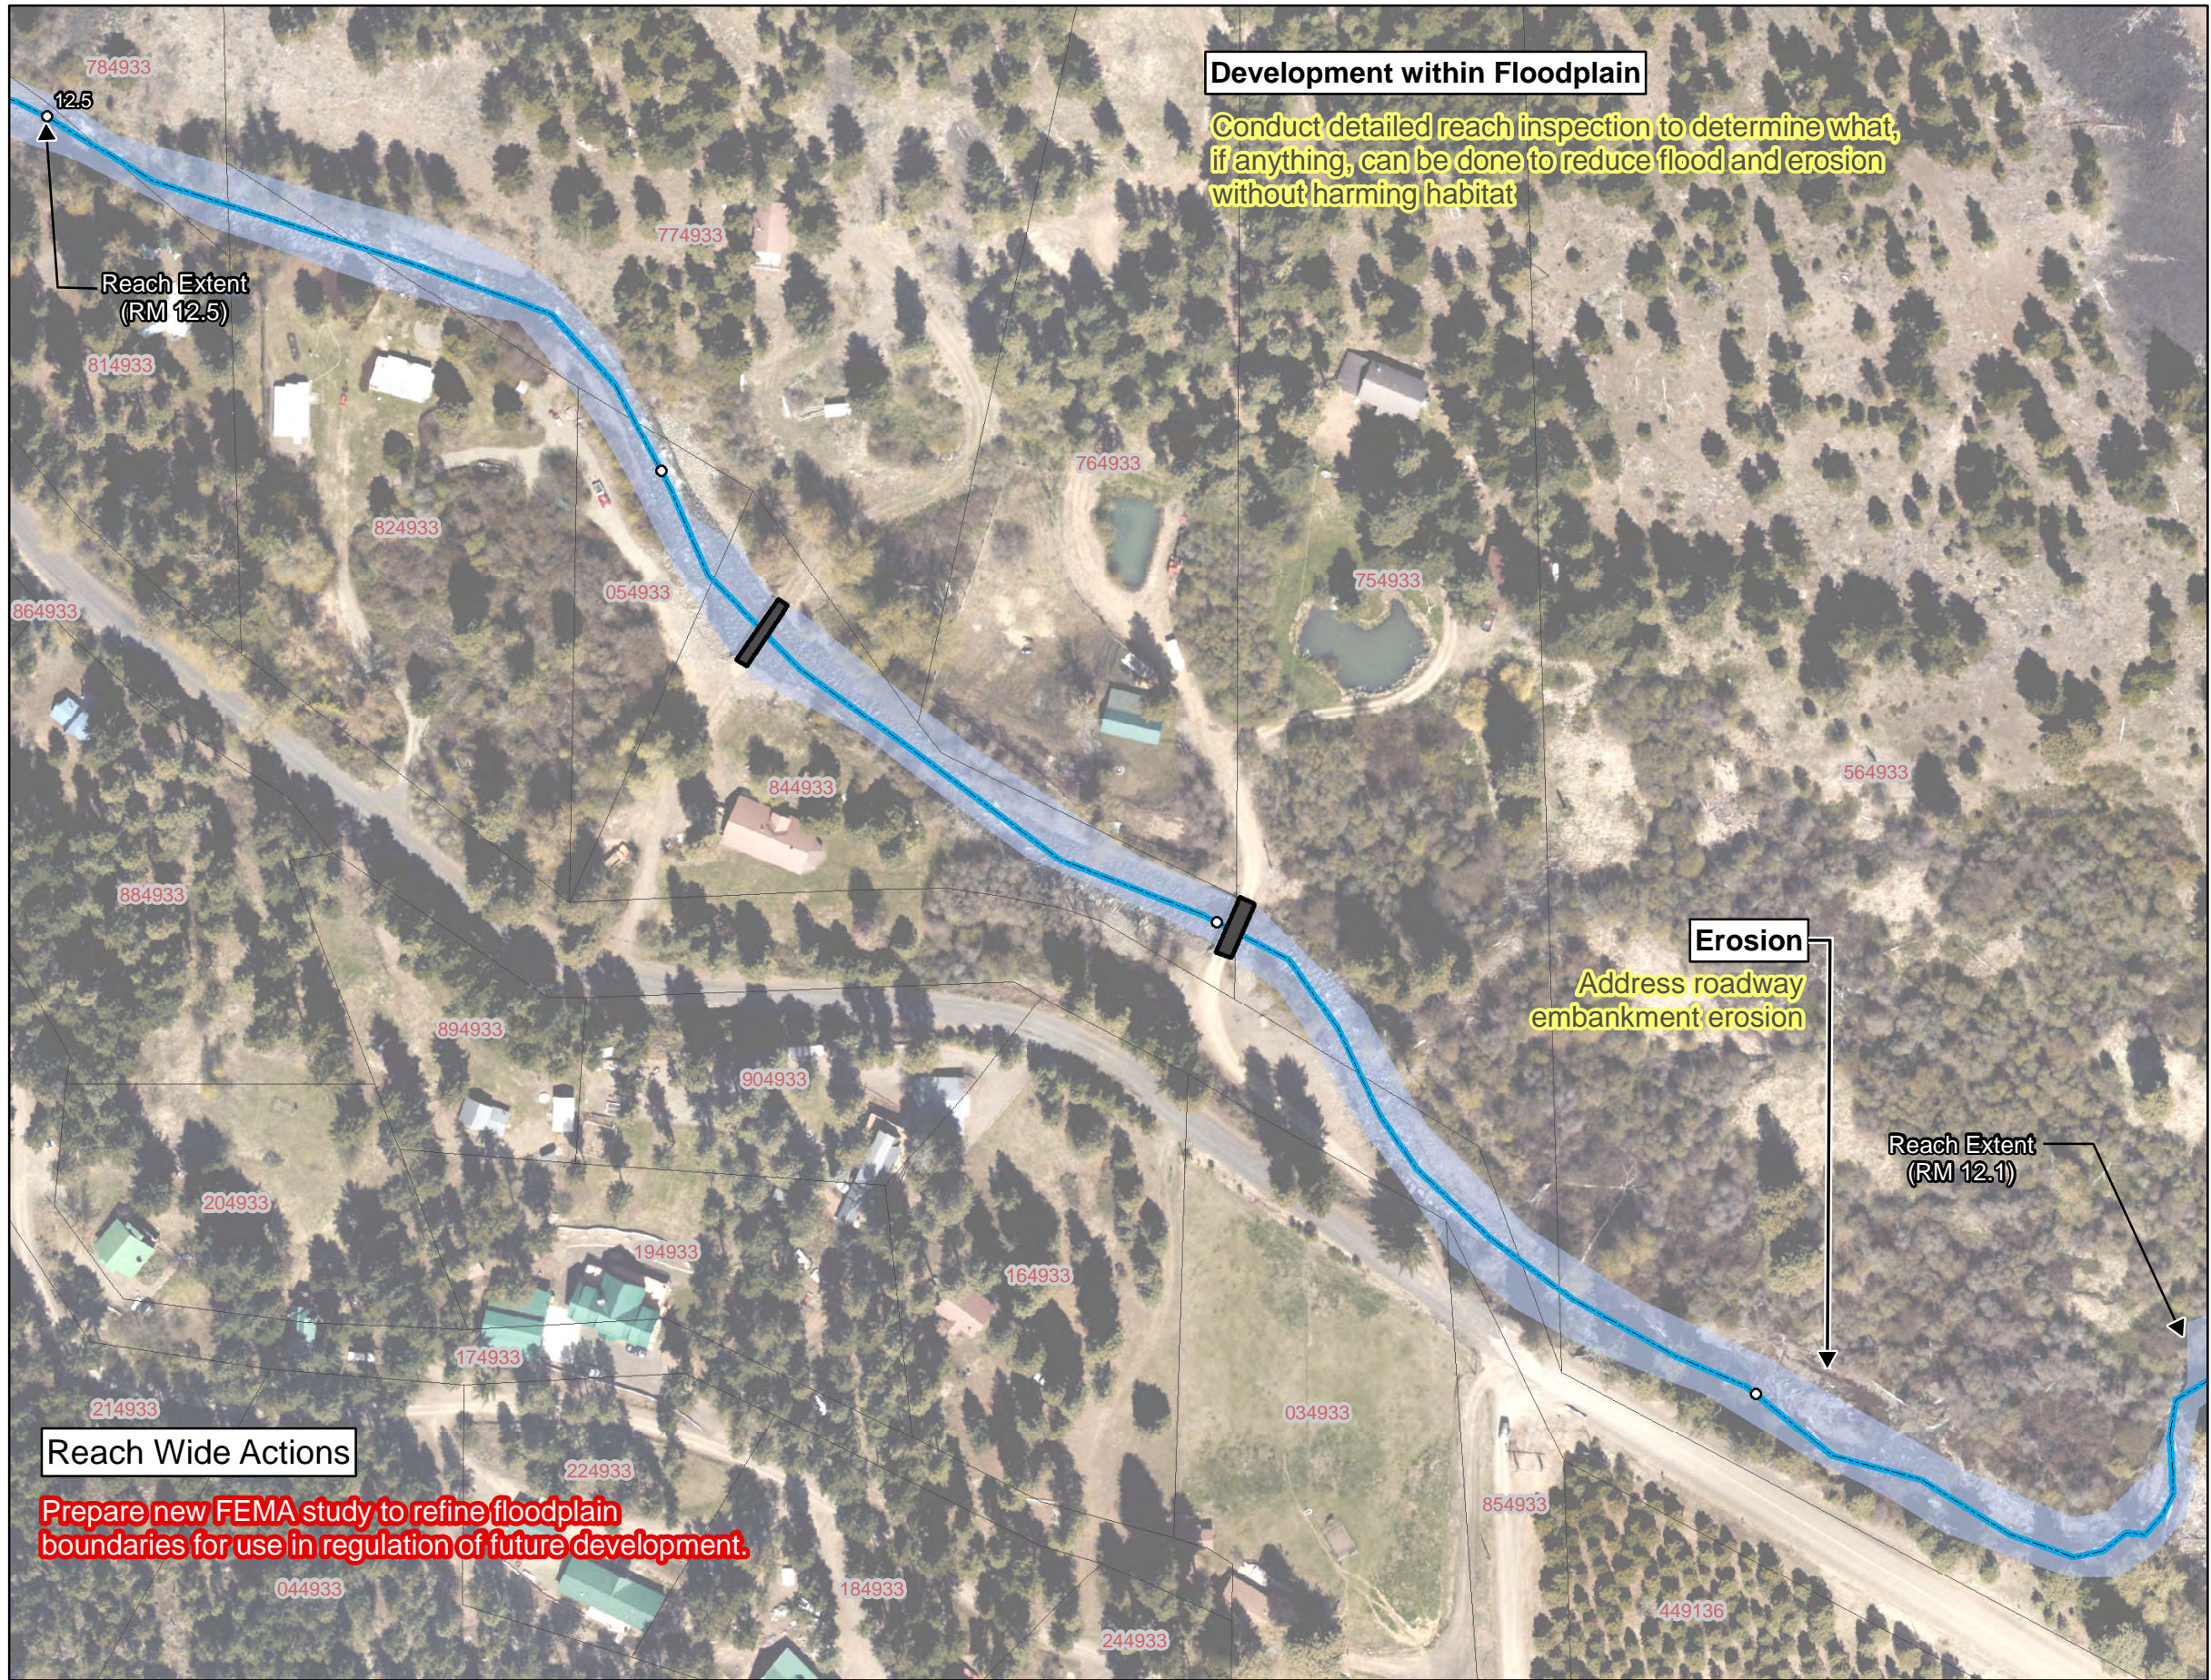
SHEET 20

20-2	Reinforce roadway embankment and enhance habitat using large rock and wood structures.	10/20	KCFCZD Kittitas County Public Works	Kittitas County Public Works

Project Reach 20:
Mitchell Road Reach
(RM 12.1 to RM 12.5)
